**INVESTIGATION OF THE CHALLENGER  
ACCIDENT**

**R E P O R T**

**COMMITTEE ON  
SCIENCE AND TECHNOLOGY  
HOUSE OF REPRESENTATIVES**

**NINETY-NINTH CONGRESS  
SECOND SESSION**

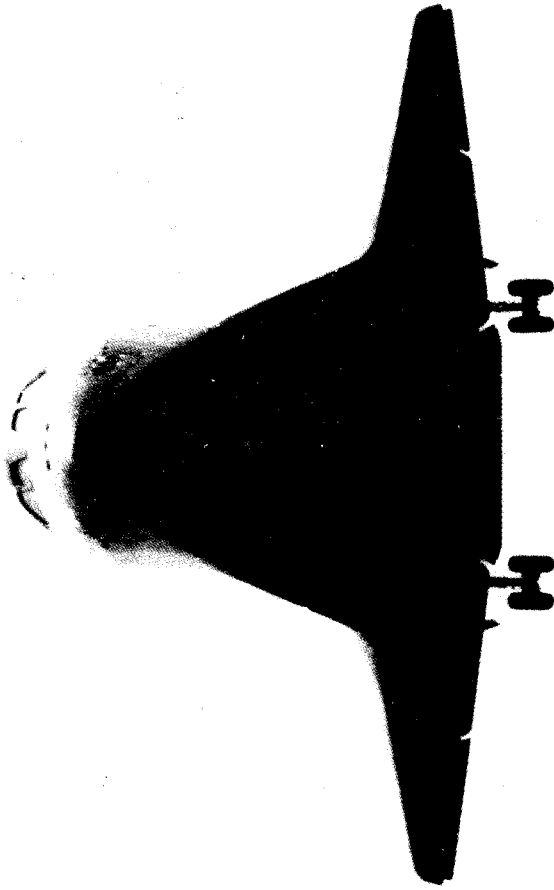
FIGURE VI-1

The *brakes* by all standards are very large, very light, of conventional configuration, and very experimental because of extensive stretching of materials technology by using carbon-beryllium. Brake design is not rigorous, it is very empirical and results are often unpredictable in new designs. The Orbiter brakes incorporate beryllium stators and carbon lined beryllium rotors. Beryllium has low density, high strength, and high heat capacity. Beryllium is very tender and not well behaved at high temperatures. Beryllium has unreliable plastic characteristics at higher temperatures. Use of beryllium in lieu of steel saved perhaps 1000 pounds in the cumulative landing gear weight. The C-5A aircraft uses beryllium rotors and stators.

For the first 23 Orbiter flights, brake damage occurred to varying degrees on 15 flights for a sum of 32 damaged brakes. Failure seemed to favor the right hand gear. A great majority of these damages were not necessarily associated with heavy demands. A very few were caused by approaching the design energy absorption. A case cannot be made against the heavy footed pilot. Regression analysis indicates that there are no significant trends that show brake damage is a function of energy demands within limits, peak demands, or landing weight. It appears that the brakes, relieved of asymmetric steering loads, will approach design energy absorption specifications for one landing but those specs are inadequate to current requirements for repetitive operations.

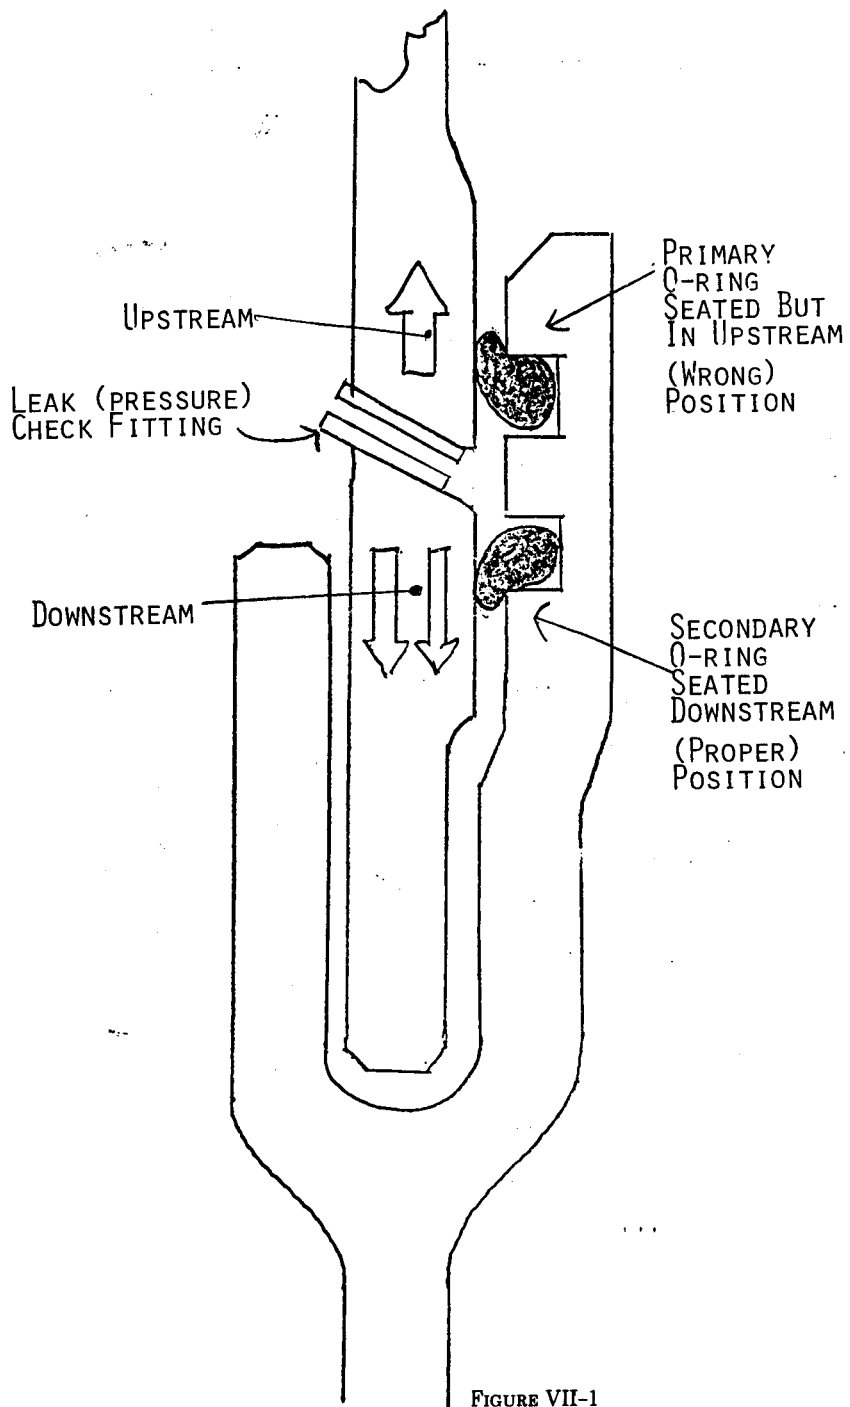
FIGURE VII-1

2. Upon ignition, the primary O-ring could not reseal at the 300 degree location in the downstream position, where it needed to be in time to prevent blowby. At this point there were too many deficiencies acting in unison which prevented the O-ring from reseating in that location. First, proper spacing between the inner face of the tang and the opposing face of the inner leg of the clevis approximately 0.020 inches, is critical. That spacing for Flight 51-L was too small, at the 300 degree location where the smoke was observed, to facilitate prompt reseating of the primary O-ring. Calculations of segment diameters indicate the gap spacing was only 0.004 inches, near metal-to-metal contact. The ignition gases passed the O-ring at this location (See Figure VII-2). This condition did not exist elsewhere in the joint around the casings since the primary O-ring was able to seat around the joint in other locations.

Second, the low temperature throughout the night prior to launch left the fluorocarbon elastomer primary O-ring stiff and lacking in ability to spring into the downstream (seated) position at the 300 degree location in time, relative to the buildup of motor pressure, to provide a tight seal. The temperature of the aft field joint at time of launch was calculated by Thiokol after the accident to be 16 degree F. Part of the reason for this low temperature was the heat transfer away from the joint, by conduction through the aft attachment strut. The conduction was driven by liquid hydrogen, which remained in the external tank overnight. The supercold fuel created a 430 degree temperature differential across the ship, drawing heat out of the joint and O-rings.

At ignition, blowby occurred, either with erosion of the primary O-ring or without erosion.

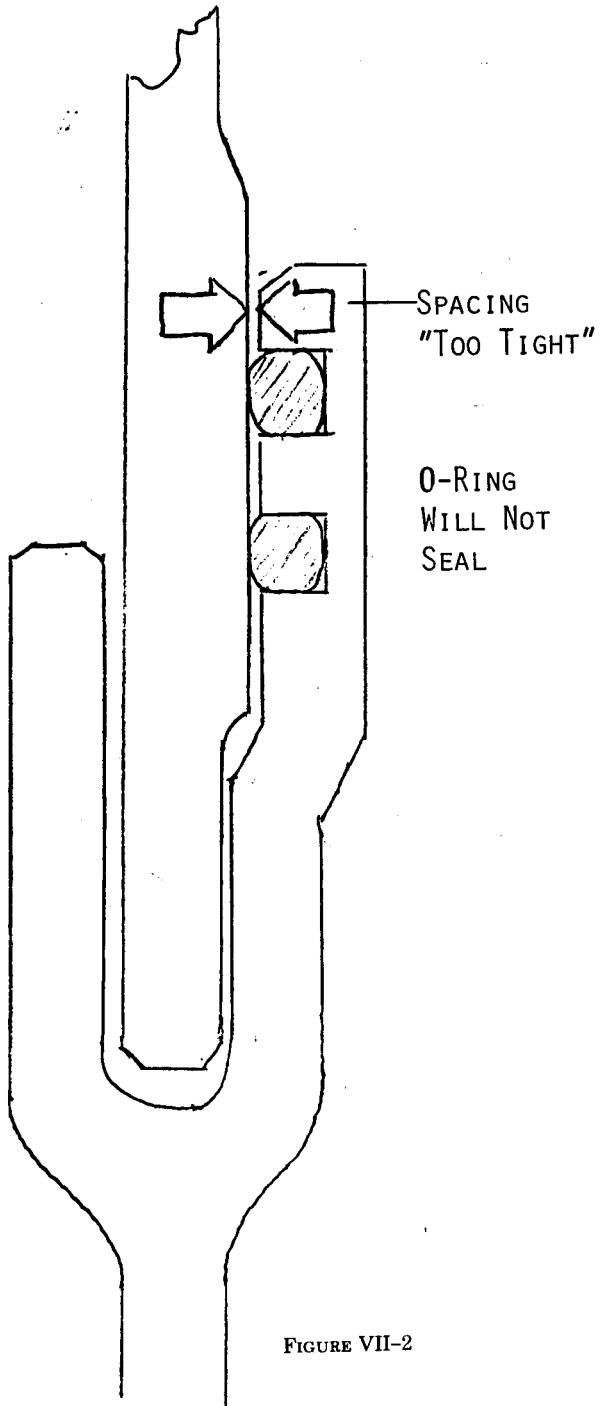
3. However, there could have been one or more than one blowhole through the zinc chromate putty before ignition. One such blowhole could have been made at the 300 degree location either during the leak check at 200 psi prior to the seating of the primary O-ring or prior to the leak check when the casings were brought together. If so, there was a high probability that the primary O-ring eroded at this point. The phenomena of blowing holes in the putty had been observed many times at post-flight dismantlement and had dramatically increased when the procedures were changed to increase the test pressure to 200 psi. Additionally, the Randolph putty had been found unsatisfactory on numerous occasions.<sup>2</sup>

4. Upon ignition of the Solid Rocket Motor, this blowhole would have facilitated and concentrated the hot propellant gas flame on the primary O-ring, and possibly the secondary O-ring as well. Alignment of O-ring erosion with the location of blowholes had been observed on numerous occasions.<sup>3</sup>

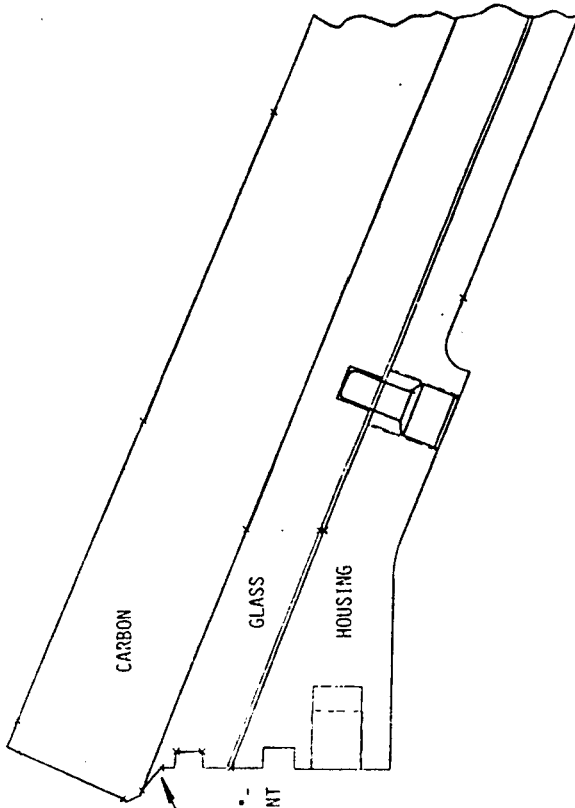
STS-61B (STS-31) (SRM-23) POST FLIGHT  
(CHART NO. 3-2A)

SOOT ON THE  
GLASS, (2) ARCS-  
108°-193° AND 221°-  
285°, JUST IN FRONT  
OF THE O-RINGS.
