Report to the President

**PRESIDENTIAL  
COMMISSION**

On the Space Shuttle  
Challenger Accident

June 6th, 1986  
Washington, D.C.

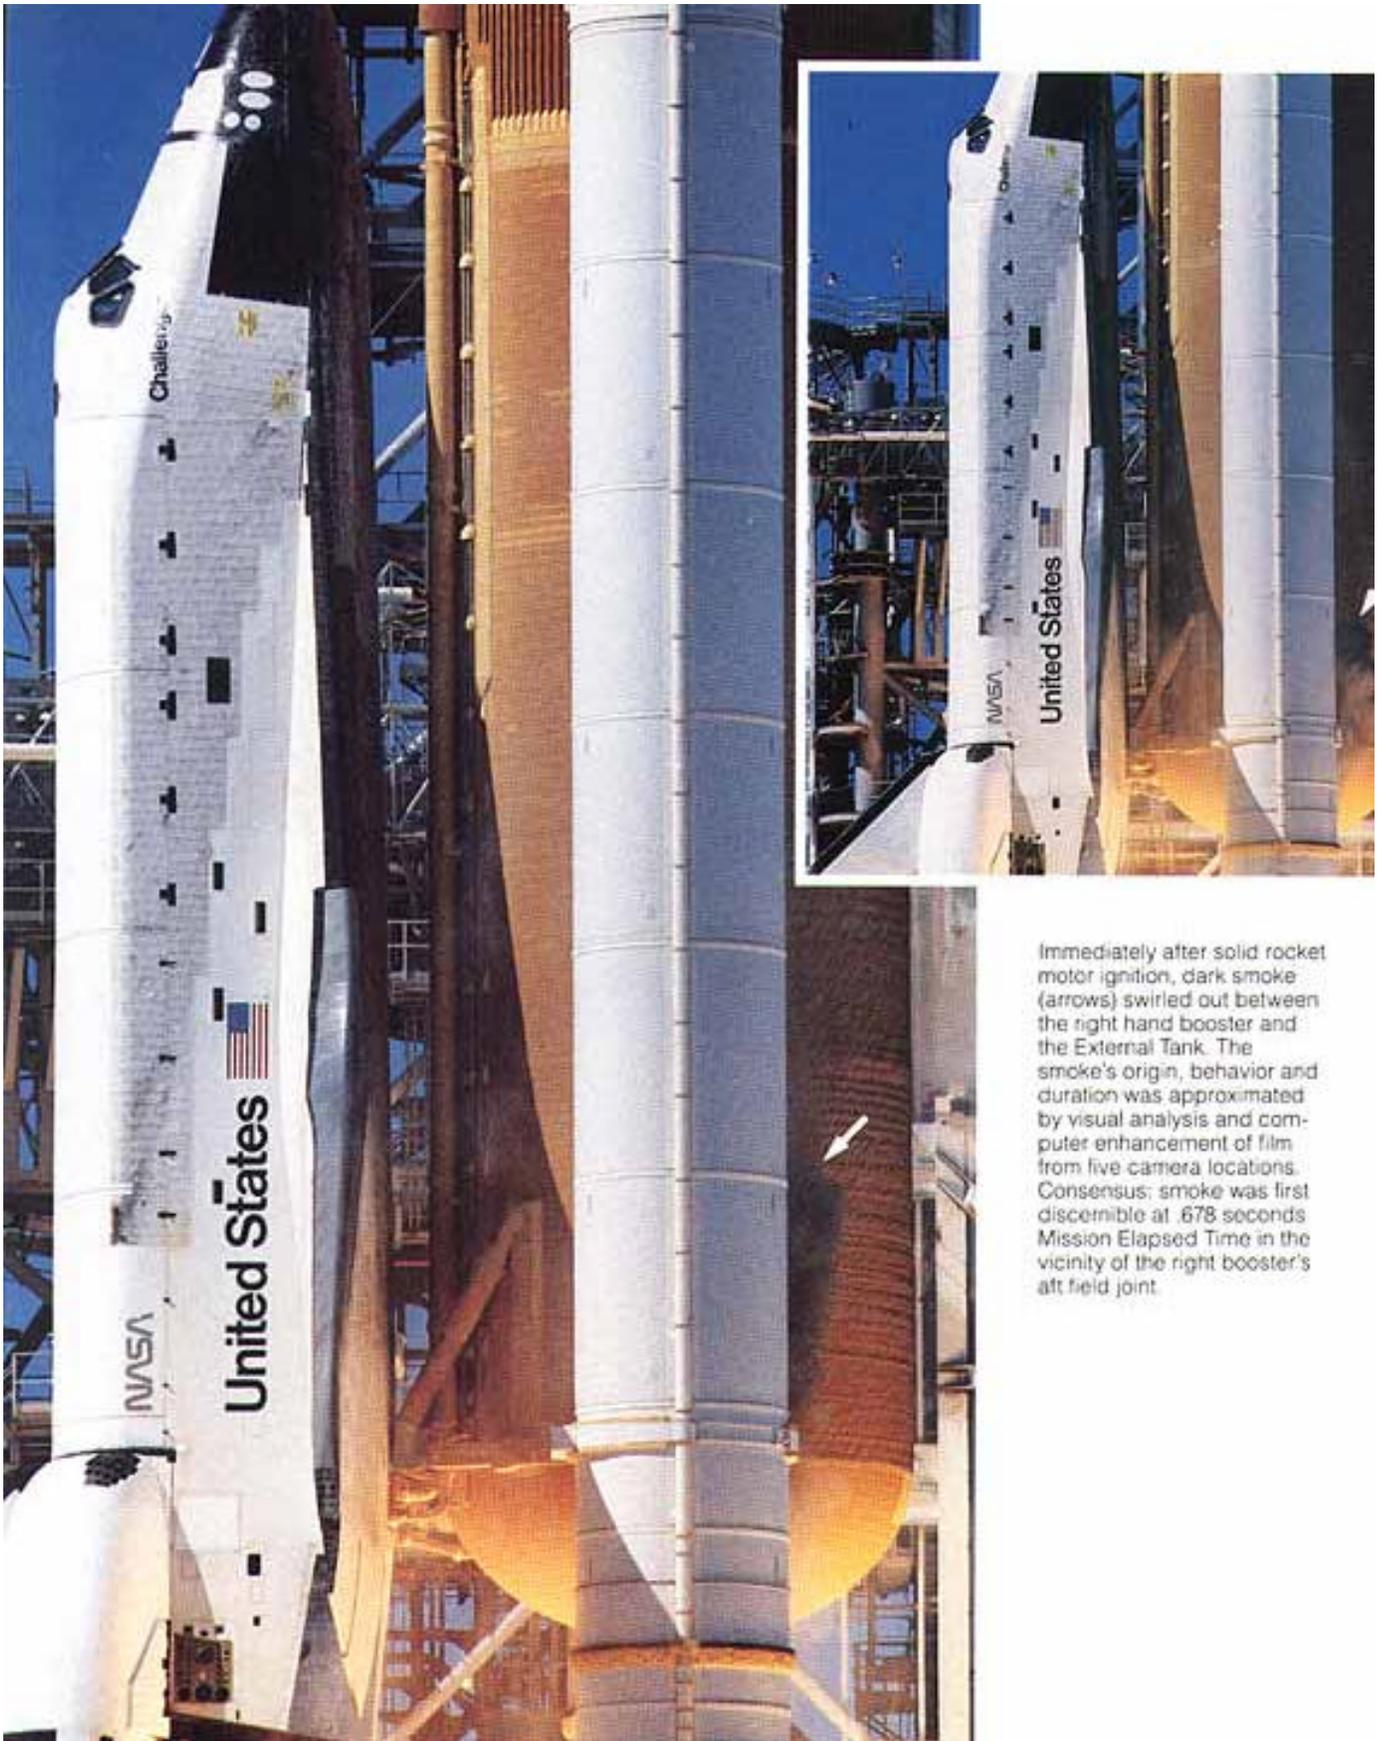
Immediately after solid rocket motor ignition, dark smoke (arrows) swirled out between the right hand booster and the External Tank. The smoke's origin, behavior and duration was approximated by visual analysis and computer enhancement of film from five camera locations. Consensus: smoke was first discernible at 678 seconds Mission Elapsed Time in the vicinity of the right booster's aft field joint.

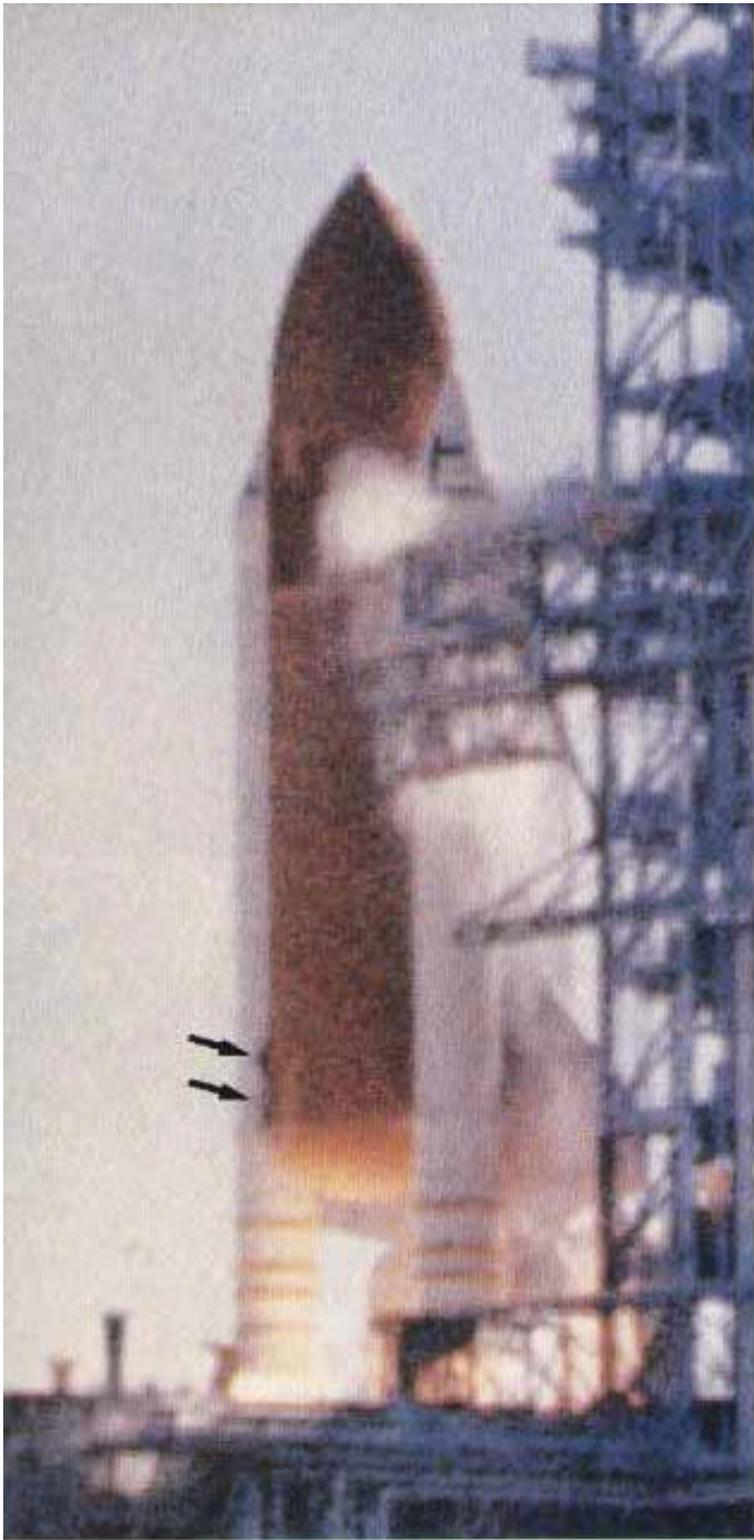
Multiple smoke pulls are visible in the photo above (arrows). They began at .835 seconds and continued through 2.500 seconds, occurring about 4 times a second. Upward motion of the vehicle caused the smoke to drift downward and blur into a single cloud. Smoke source is shown in the computer generated drawing (far right).

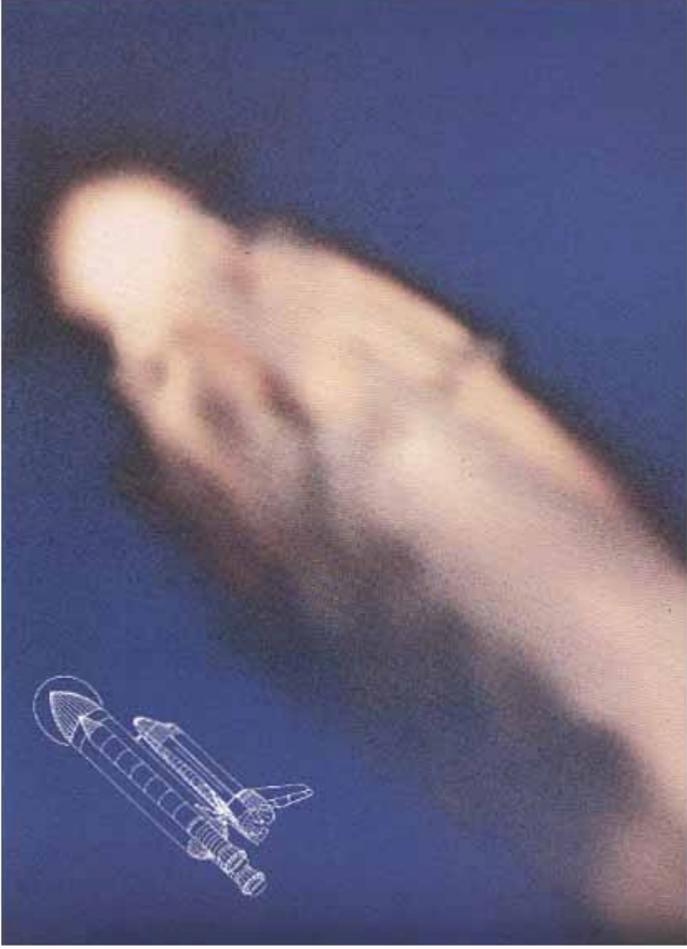
Camera views indicate the beginning of rupture of the liquid hydrogen and liquid oxygen tanks within the External Tank. A small flash (arrows above) intensified rapidly, then diminished

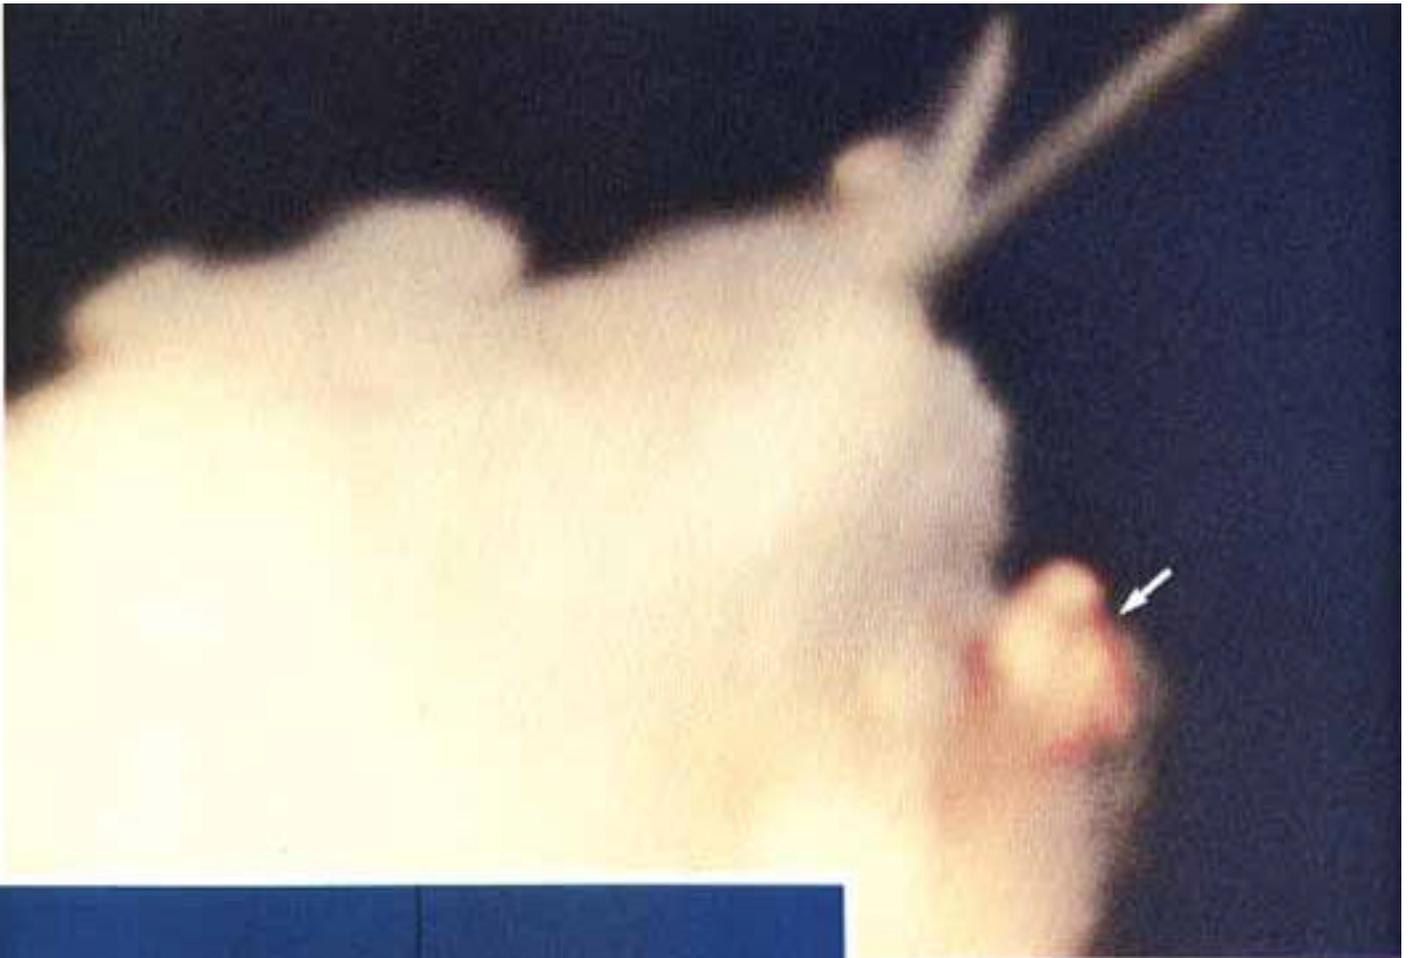
A second flash, attributed to rupture of the liquid oxygen tank, occurred above the booster/tank forward attachment (below left) and grew in milliseconds to the maximum size indicated in the computer drawing.

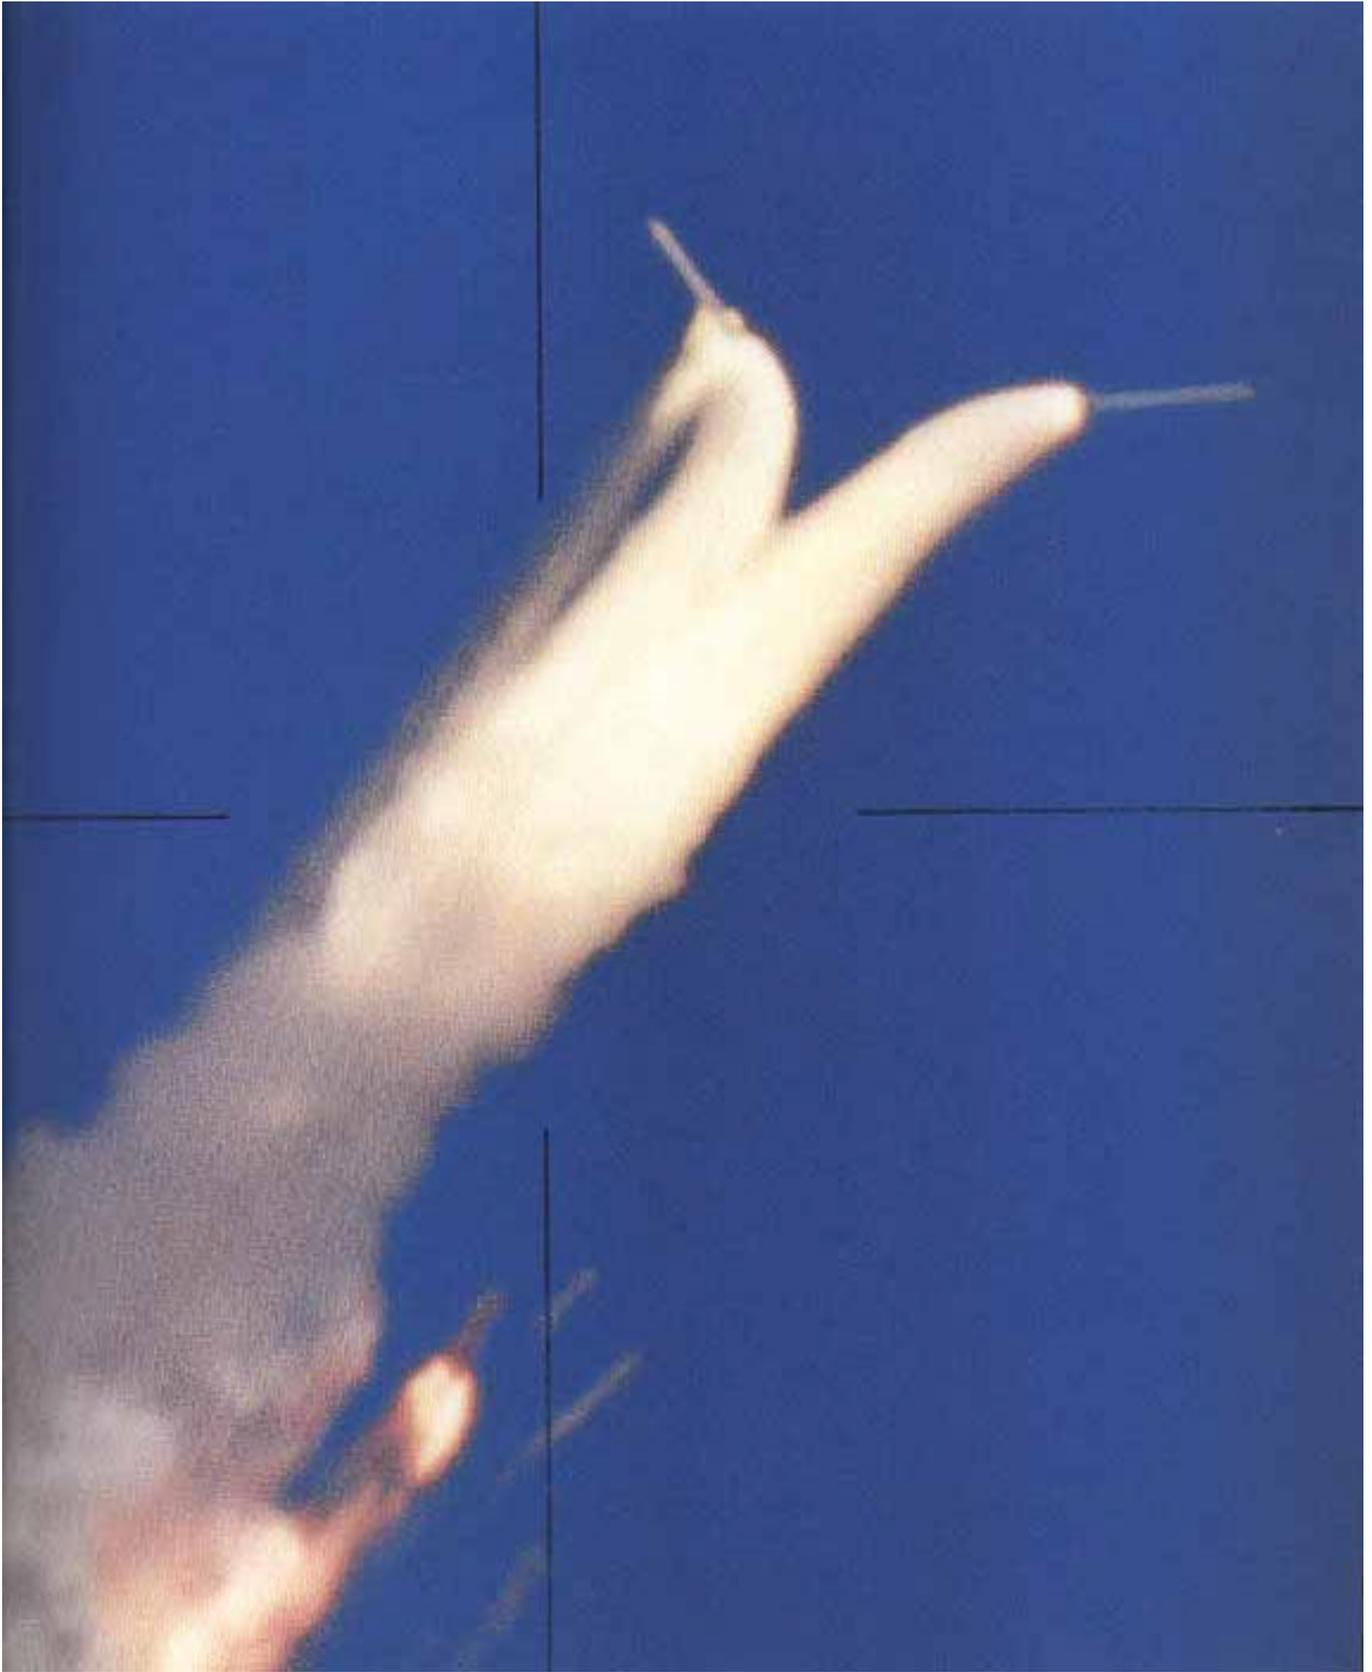
Structural breakup of the vehicle began at approximately 73 seconds. Fire spread very rapidly. Above, a bright flash (arrow) is evident near the nose of the Orbiter, suggesting spillage and ignition of the spacecraft's reaction control system propellants. At left, the two Solid Rocket Boosters thrust away from the fire, crisscrossing to form a "V." The right booster—identifiable by its failure plume—now to the left of its counterpart. At right, the boosters diverge farther; the External Tank wreckage is obscured by smoke and vapor. The Orbiter engines still firing, is visible at bottom center.

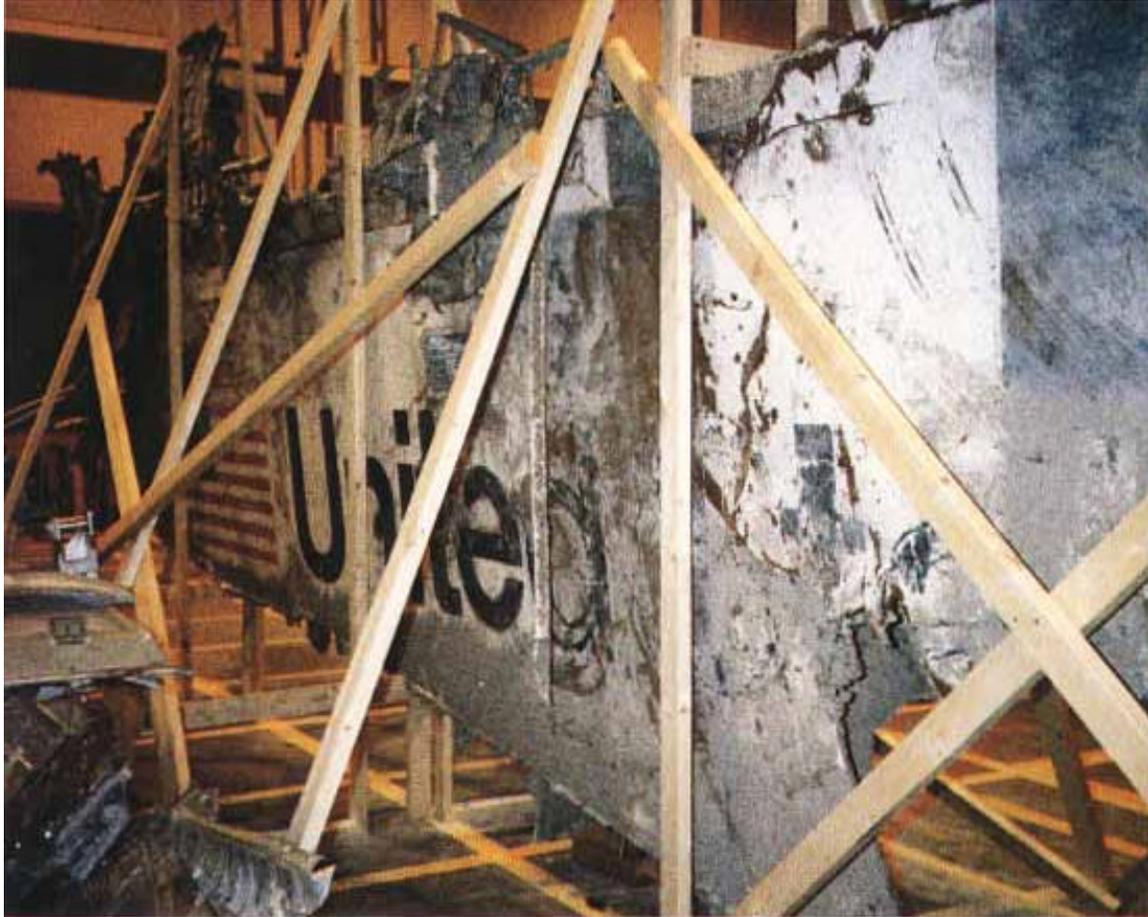
A

The upper photos show, from left to right, the left side of the orbiter (unburned), the right lower and upper rudder speed brake (both burned damaged) and left upper seed brake (unburned), confirmation that the fire was on the right side of the Shuttle stack.

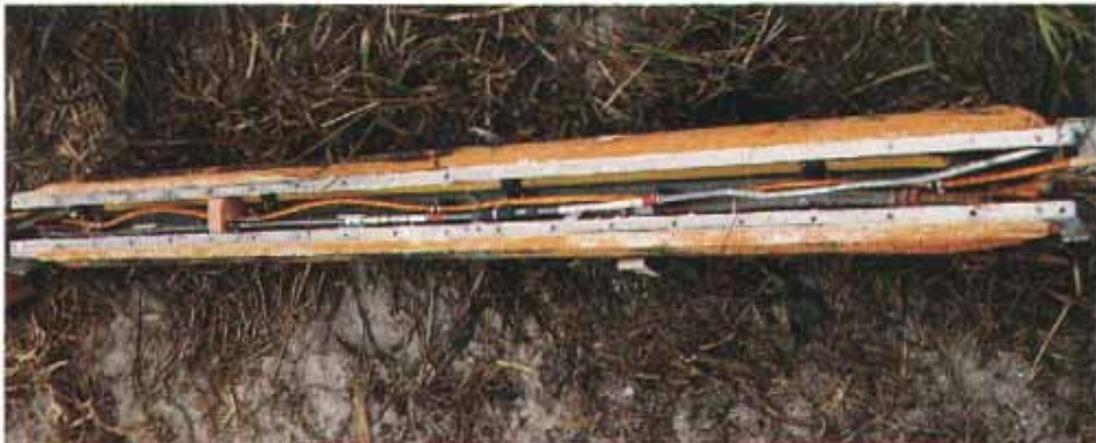
C

The lower photos show the range safety destruct charges in the External Tank. These charges were exonerated when they were recovered intact and undetonated.

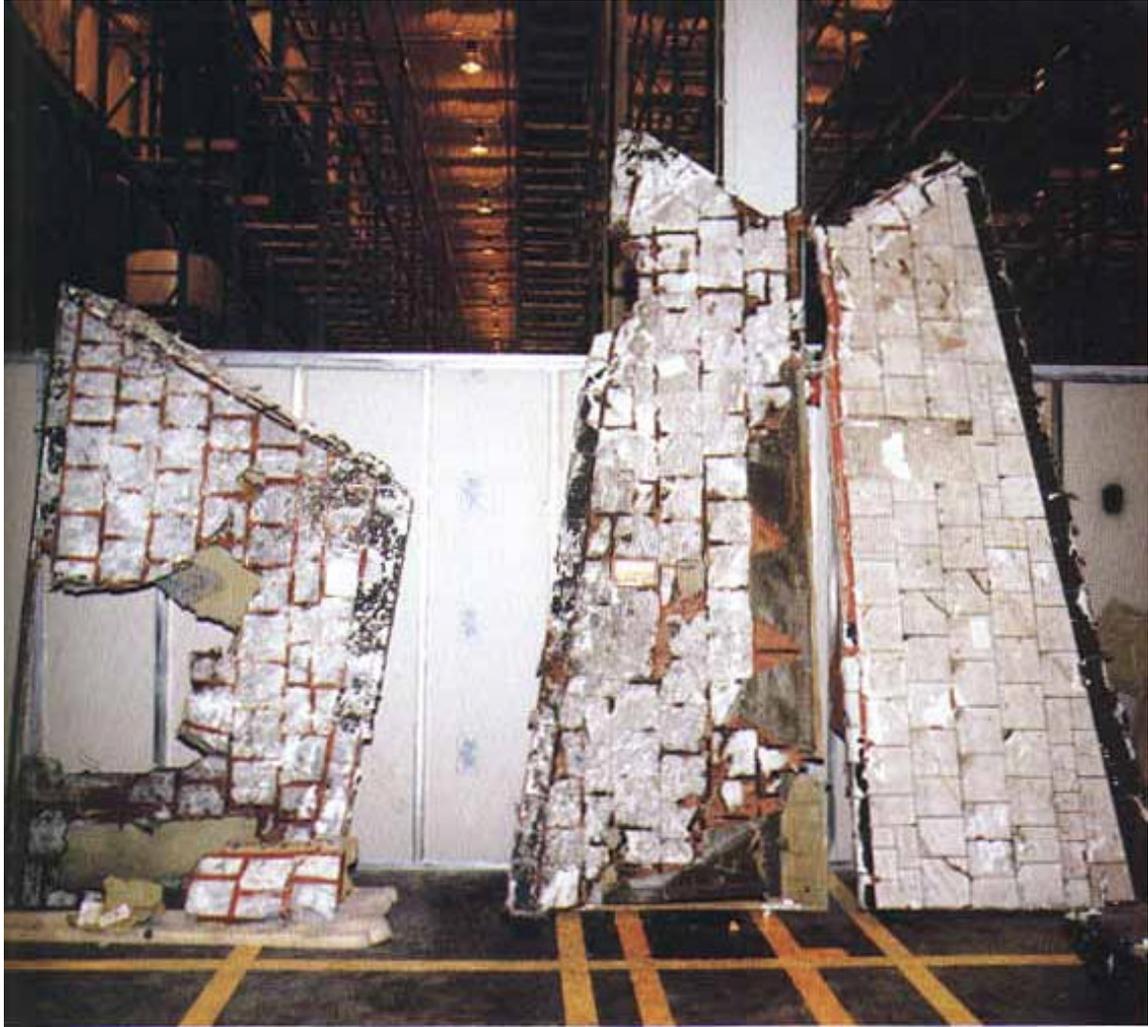
B

The upper photos show, from left to right, the left side of the orbiter (unburned), the right lower and upper rudder speed brake (both burned damaged) and left upper seed brake (unburned), confirmation that the fire was on the right side of the Shuttle stack.

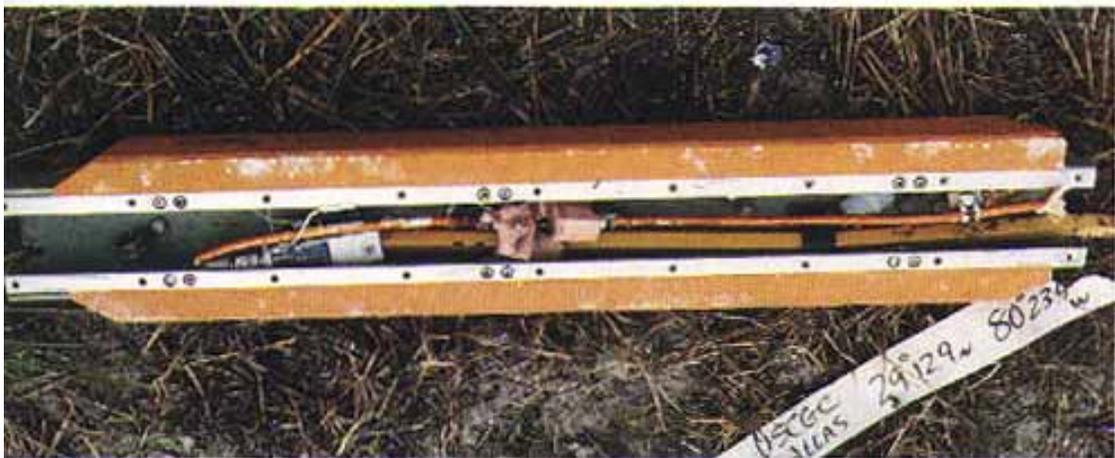
D

The lower photos show the range safety destruct charges in the External Tank. These charges were exonerated when they were recovered intact and undetonated.

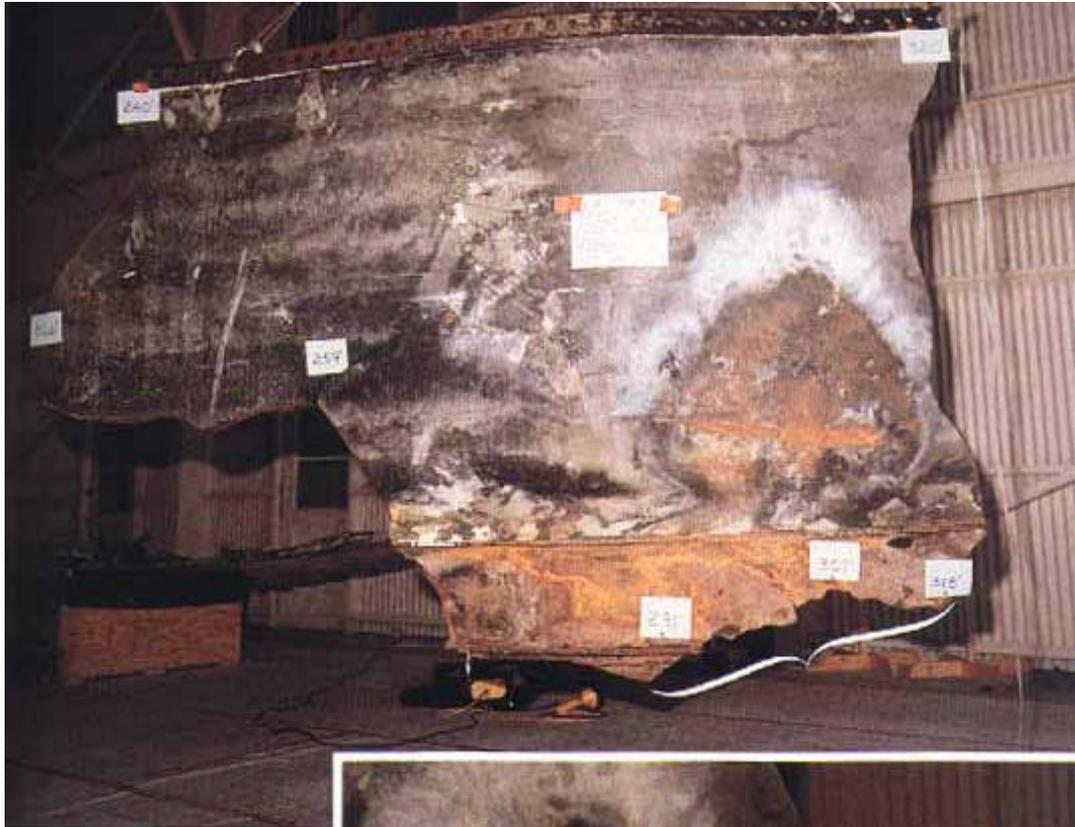
Photos L & M [top, bottom]  
Examined at Kennedy Space Center after their recovery from the ocean, these fragments show the extent of burn through the right hand booster's aft field joint. On the left page are sections of the aft center motor above the joint. On the right page are sections (inverted) of the aft motor segment showing burn-hole below the joint (bracket). Except for the interior views on lower left, the camera is viewing the parts from outside the casing.

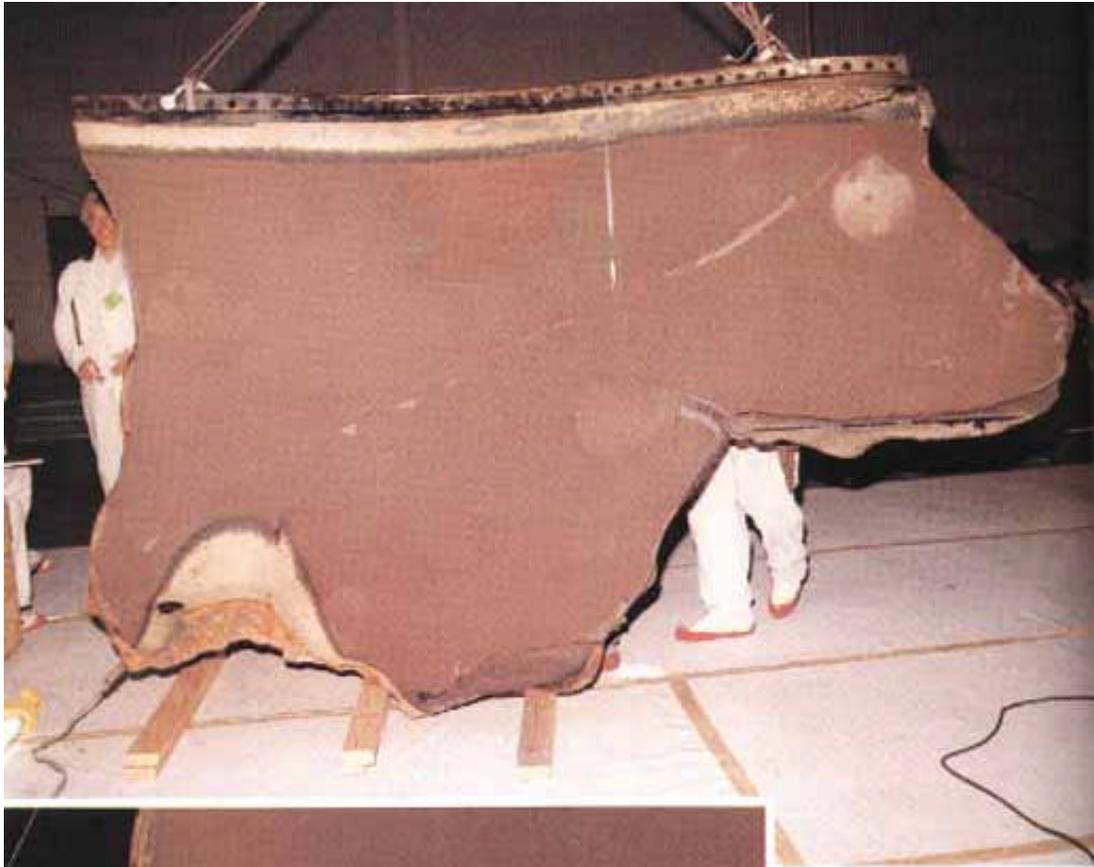
Photos N & O [top, bottom]  
At upper left is the aft segment burn viewed from inside the casing; the lower photo is a closeup of the same section. The latter photo shows a hole (arrow) where the flame plume may have burned through the casing from the outside. At right is a composite view of the burn above and below the aft field joint.

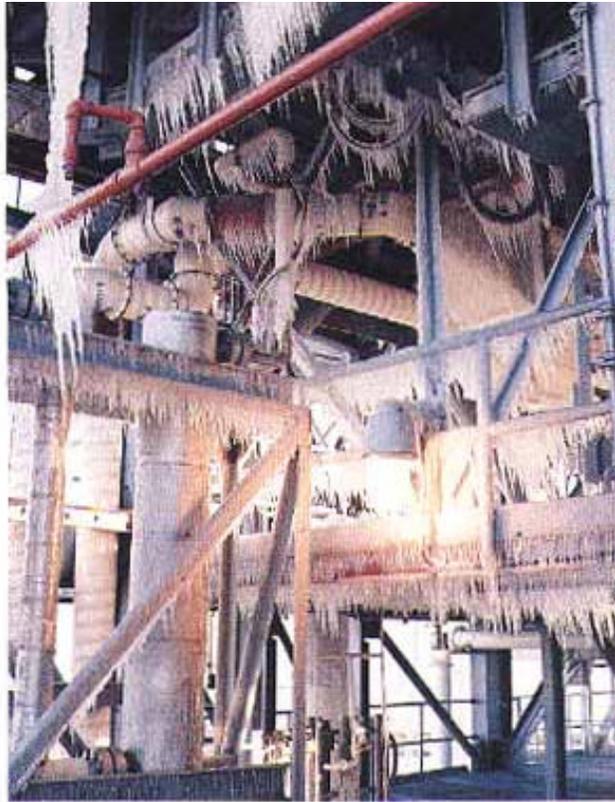
Above, foot long icicles on a lower level of the Fixed Service Structure frame the attachment point where the Orbiter is attached to the external tank (arrow). Icing was even more extensive at upper levels of the service structure (upper right and below). At right below is a ground communications box (not used during launch) rendered inoperable by heavy ice.

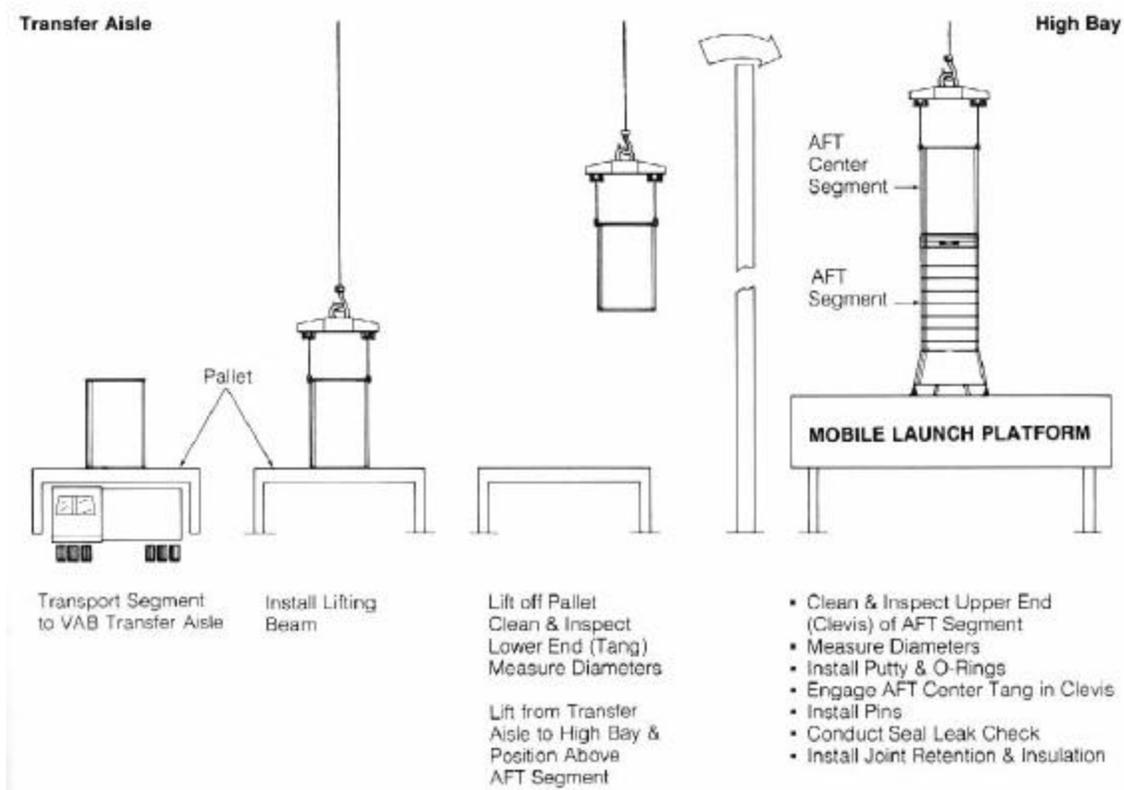
**Vehicle Assembly Building  
AFT Segment to AFT Center Segment Stack**

stacking interference. Taken across the 0-180 degree axis, the tang diameter measurement exceeded the corresponding clevis dimension by +.512 inch. The maximum allowable tang to clevis difference is +.250 inch.
