Report to the President

**PRESIDENTIAL  
COMMISSION**

On the Space Shuttle  
Challenger Accident

June 6th, 1986  
Washington, D.C.

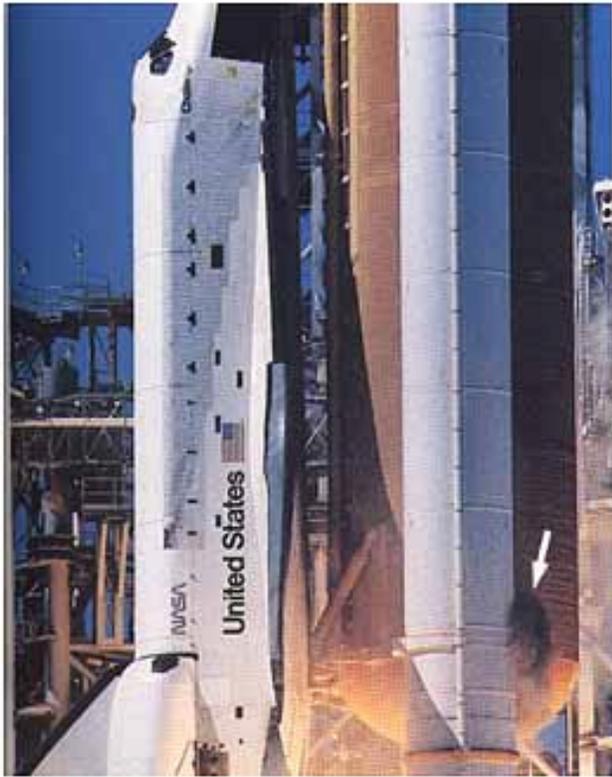
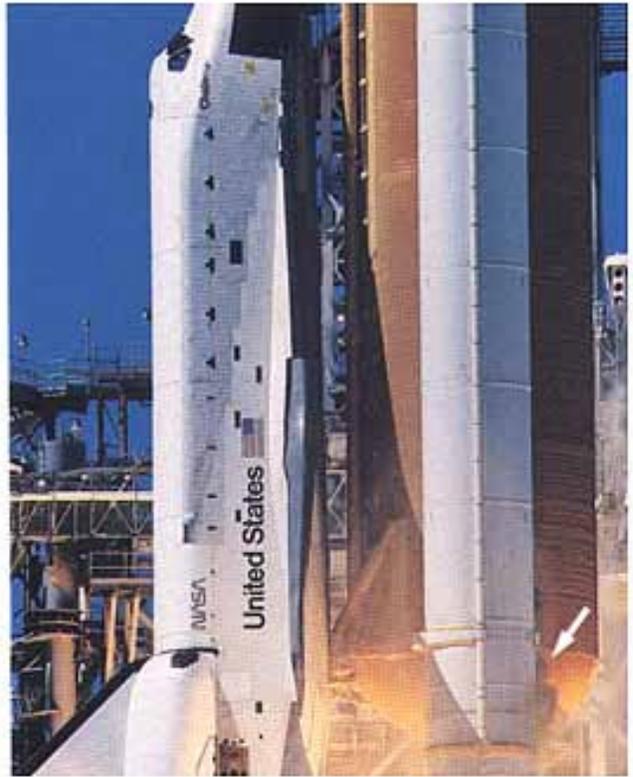
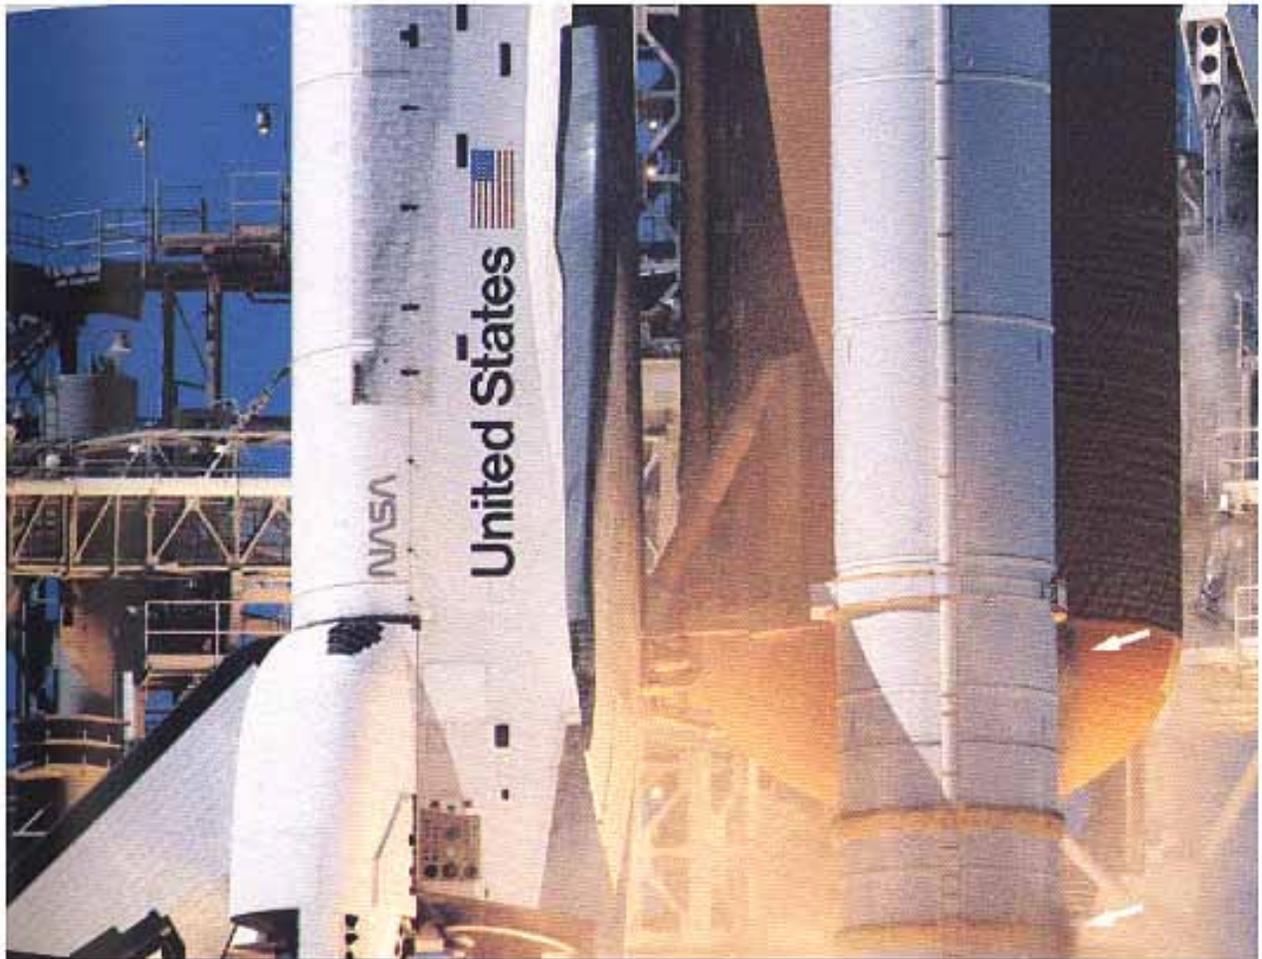
Immediately after solid rocket motor ignition, dark smoke (arrows) swirled out between the right hand booster and the External Tank. The smoke's origin, behavior and duration was approximated by visual analysis and computer enhancement of film from five camera locations. Consensus: smoke was first discernible at 678 seconds Mission Elapsed Time in the vicinity of the right booster's aft field joint.

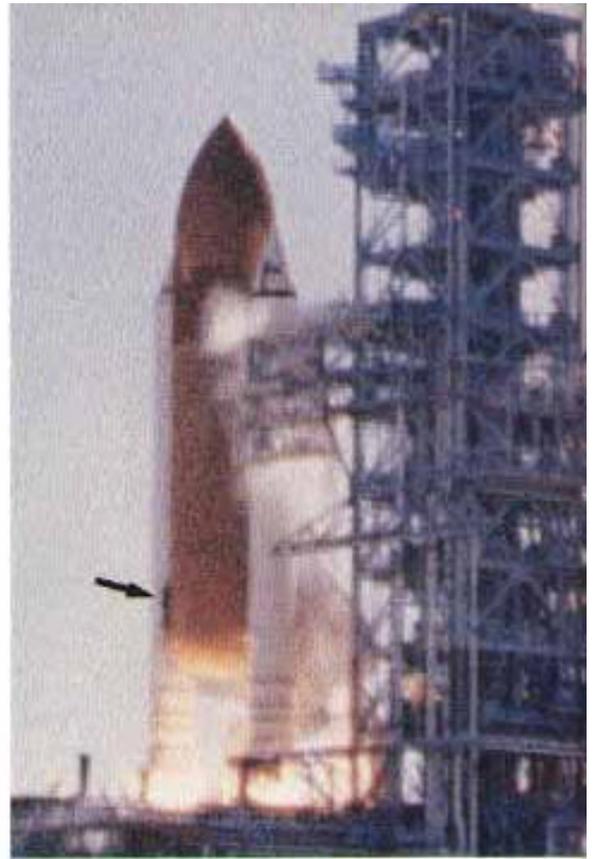
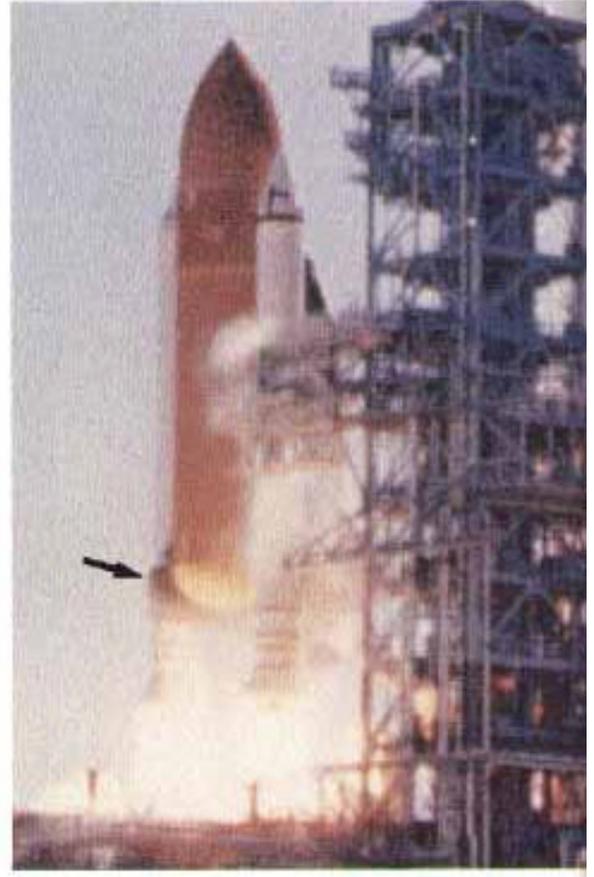
Multiple smoke pulls are visible in the photo above (arrows). They began at .835 seconds and continued through 2.500 seconds, occurring about 4 times a second. Upward motion of the vehicle caused the smoke to drift downward and blur into a single cloud. Smoke source is shown in the computer generated drawing (far right).

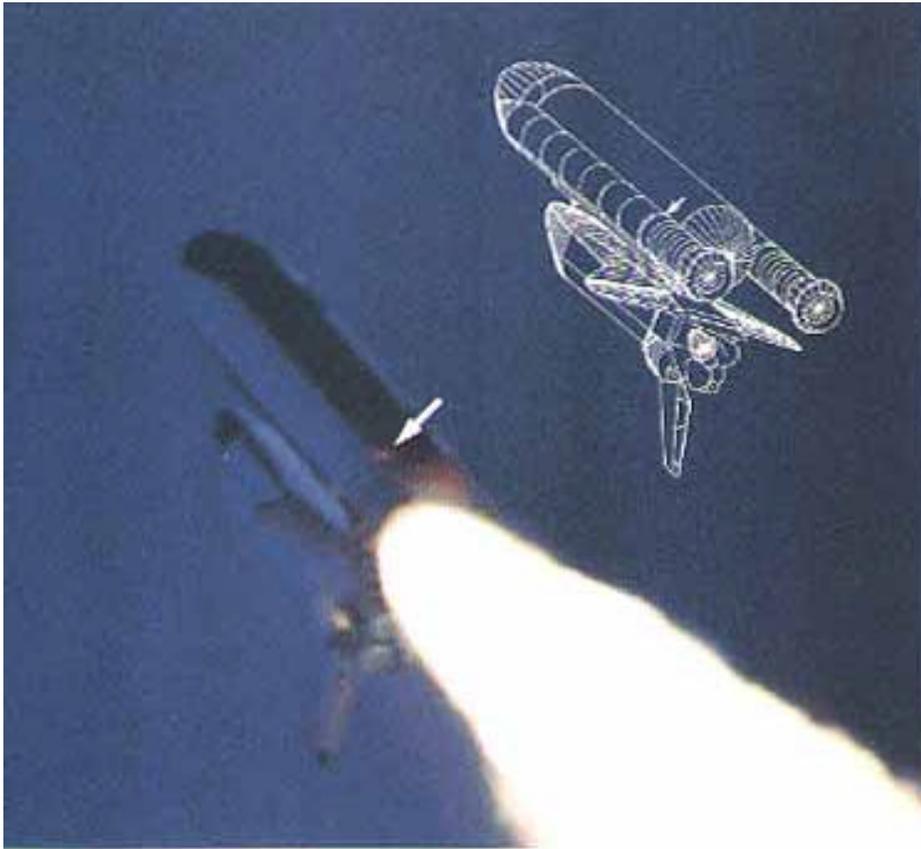
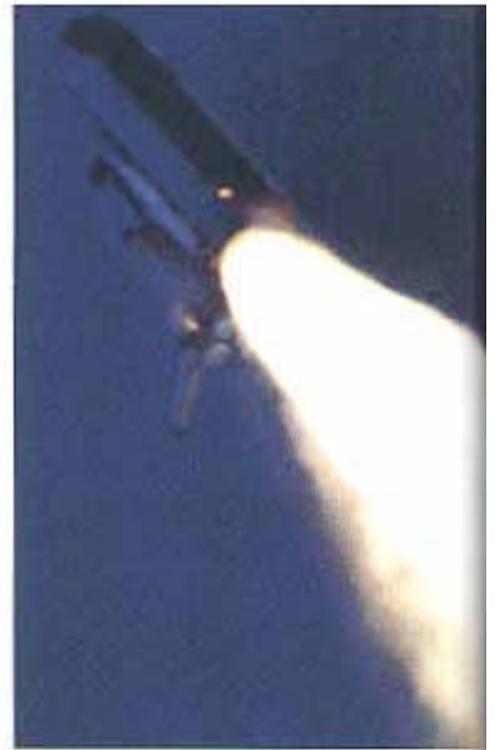
At 58.788 seconds, the first flicker of flame appeared. Flare visible above, it grew into a large plume and began to impinge on the External Tank at about 60 seconds. Flame is pinpointed in the computer drawing between the right booster and the tank, as in the case of earlier smoke puffs. At far right (arrow), vapor is seen escaping from the apparently breached External Tank.

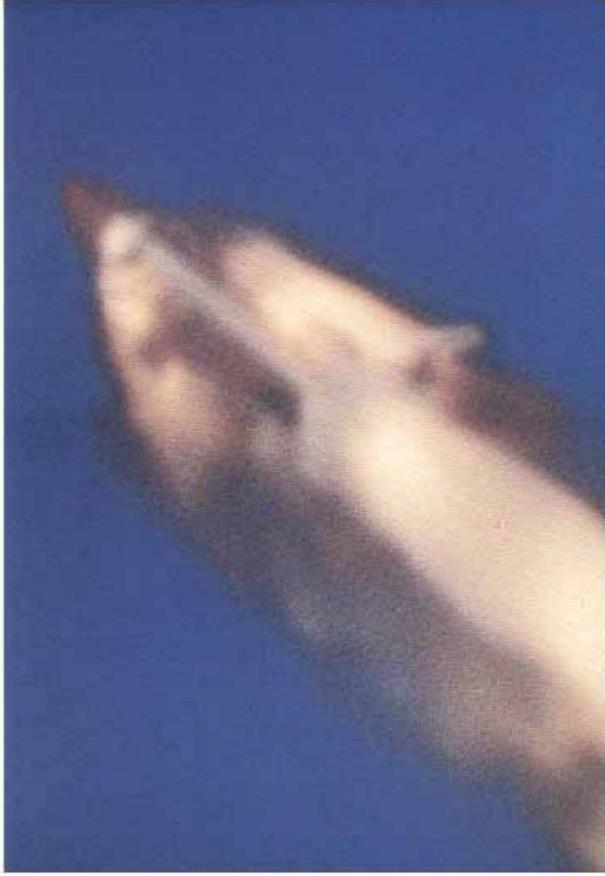
Camera views indicate the beginning of rupture of the liquid hydrogen and liquid oxygen tanks within the External Tank. A small flash (arrows above) intensified rapidly, then diminished

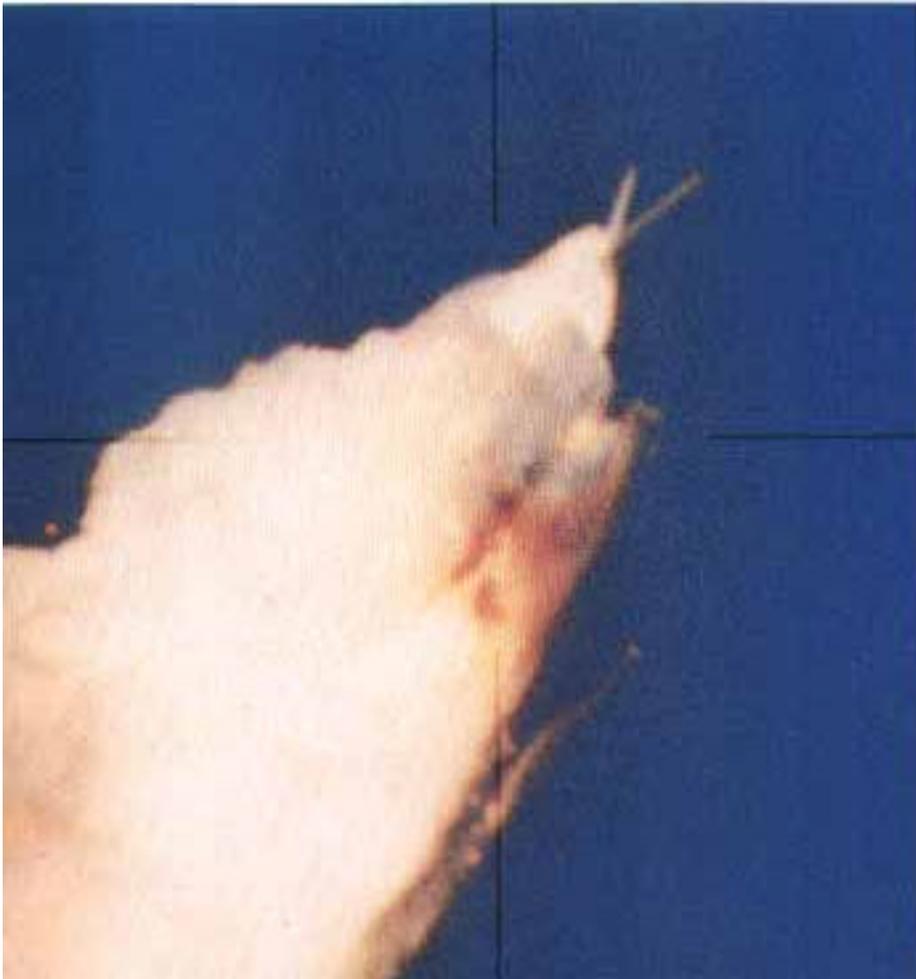
A second flash, attributed to rupture of the liquid oxygen tank, occurred above the booster/tank forward attachment (below left) and grew in milliseconds to the maximum size indicated in the computer drawing.

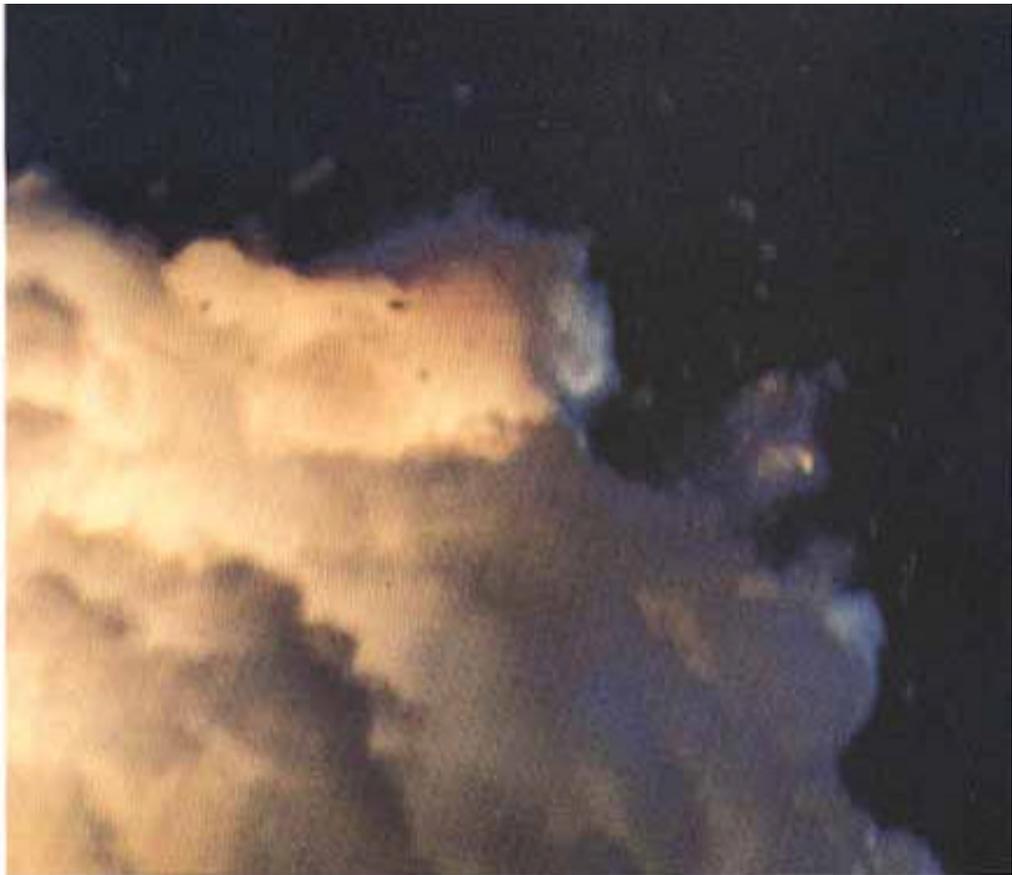
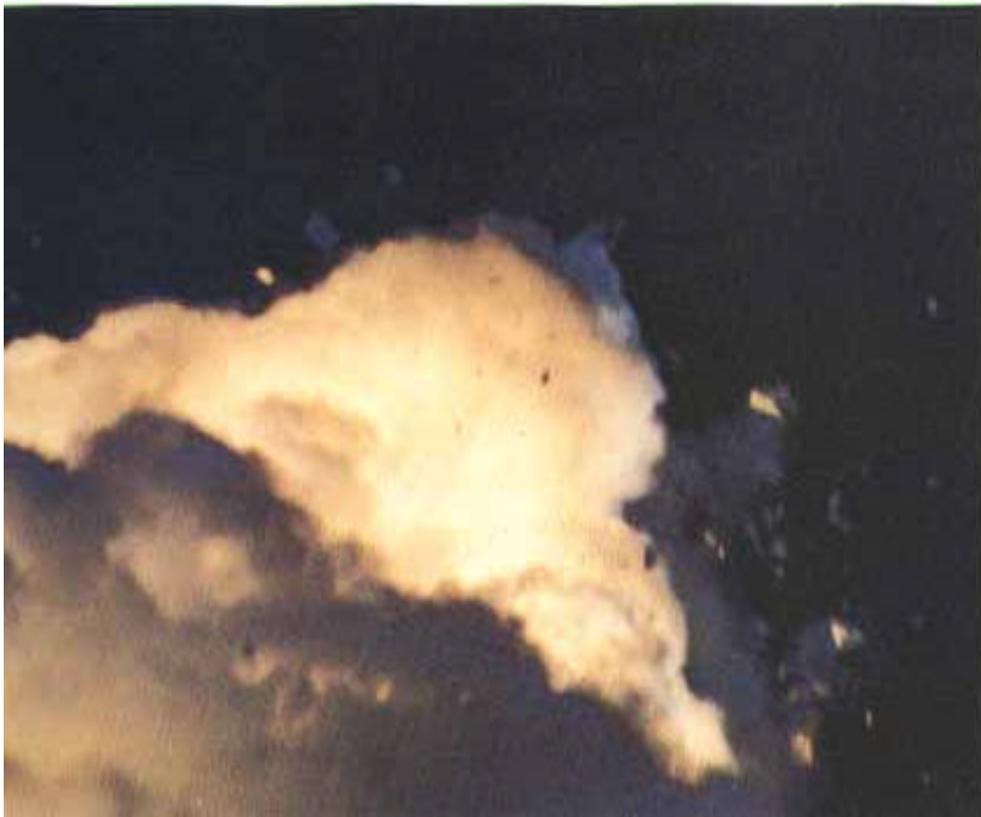
At about 76 seconds, unidentifiable fragments of the Shuttle vehicle can be seen tumbling against a background of fire, smoke and vaporized propellants from the External Tank (left).

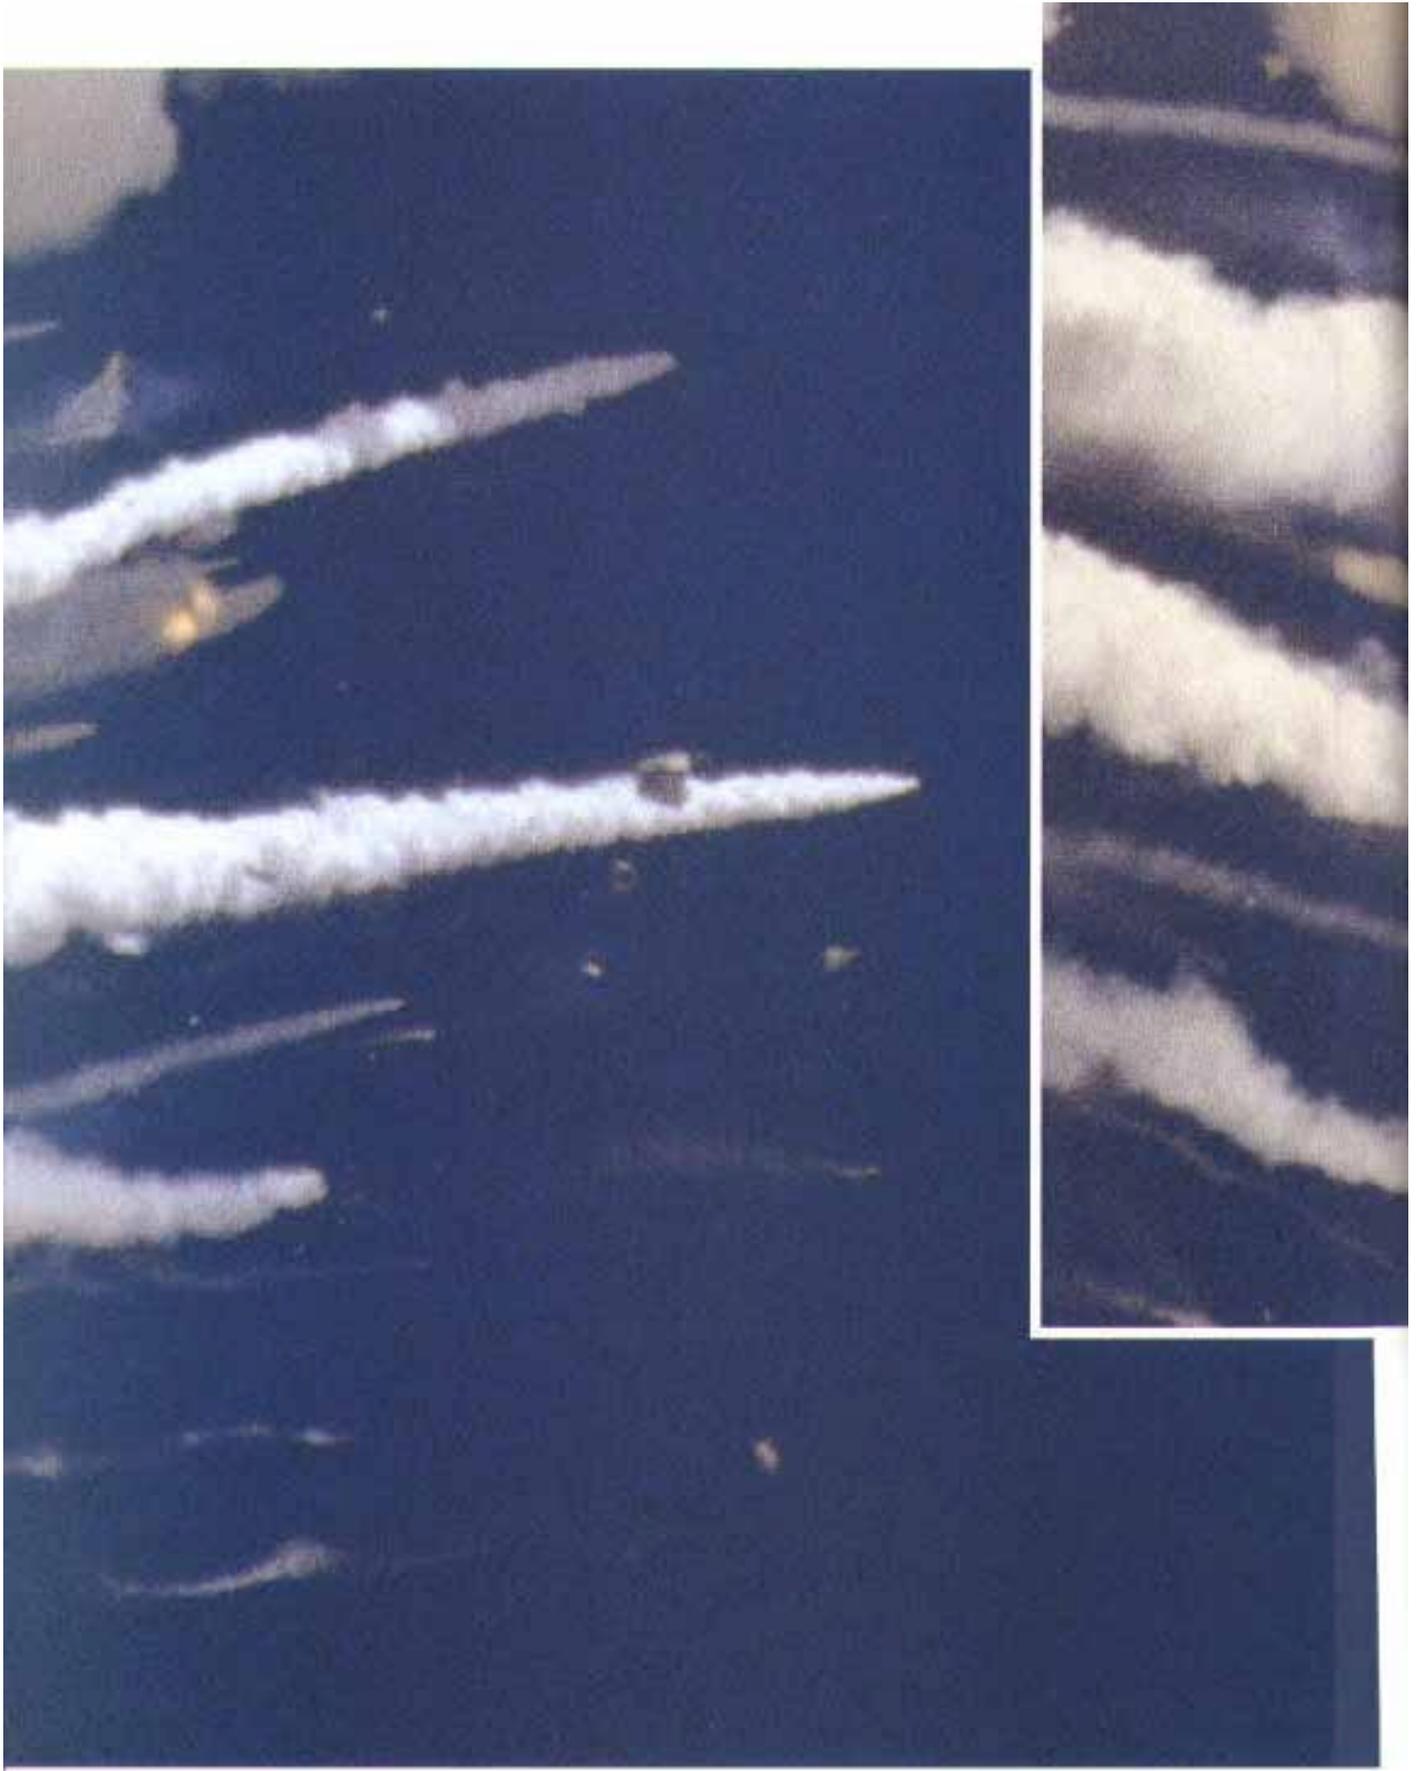
In the photo at right, the left booster (far right) soars away, still thrusting. The reddish-brown cloud envelops the disintegrating Orbiter. The color is characteristic of the nitrogen tetroxide oxidizer in the Orbiter Reaction Control System propellant

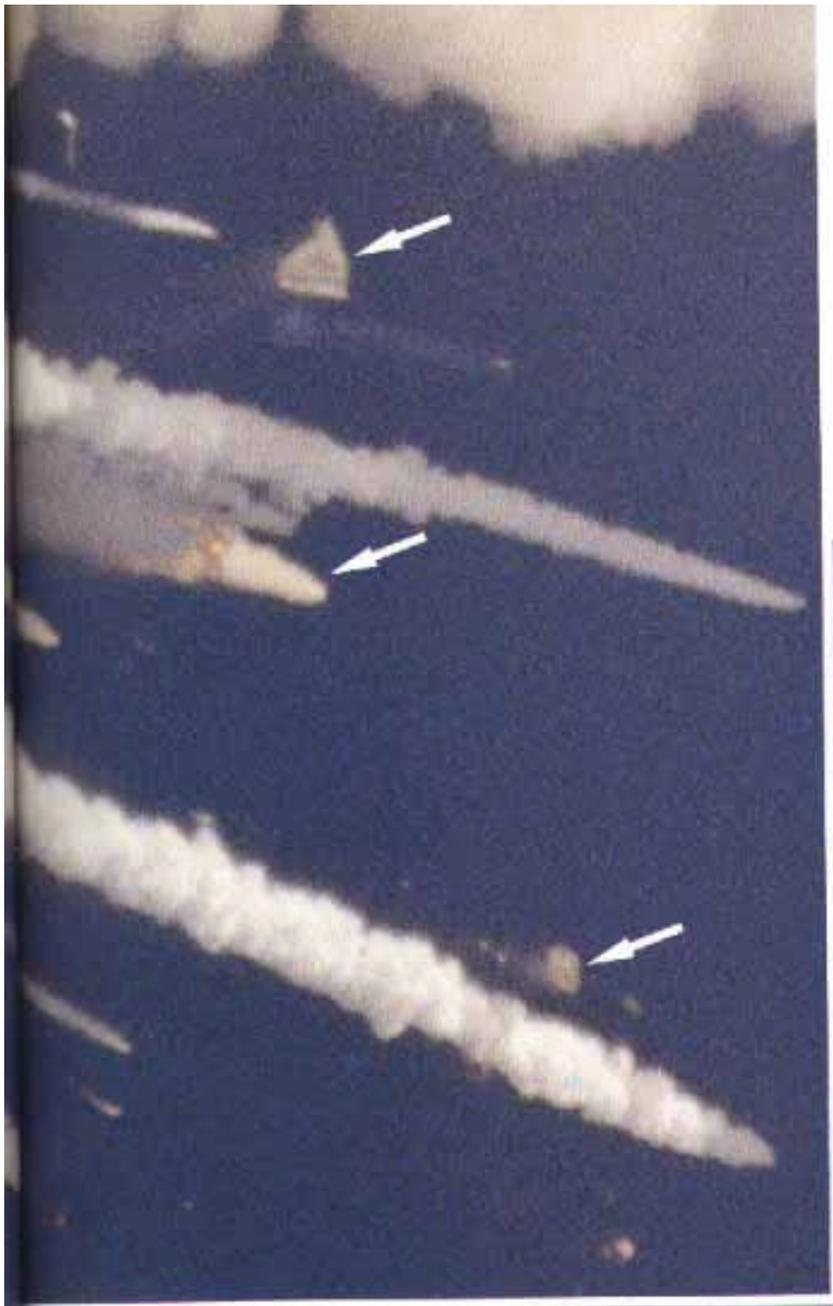
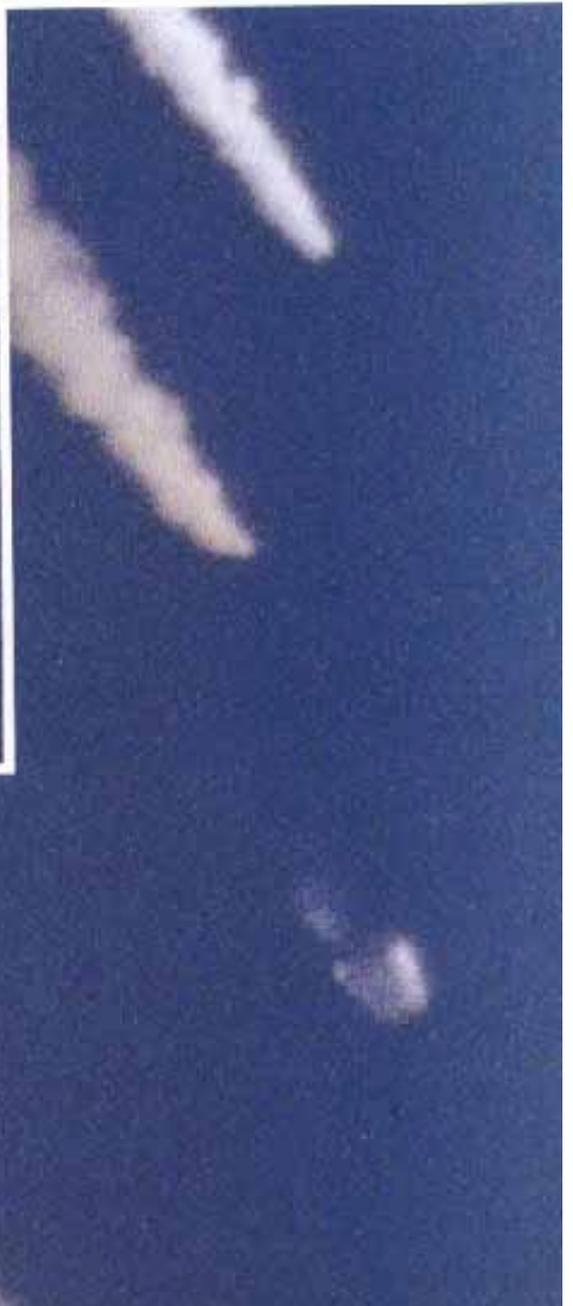
Hurting out of the fireball at 78 seconds (left) are the Orbiter's left wing (top arrow), the main engines (center arrow) and the forward fuselage (bottom arrow). In the photo below, it plunges Earthward, trailed by smoking fragments of Challenger.

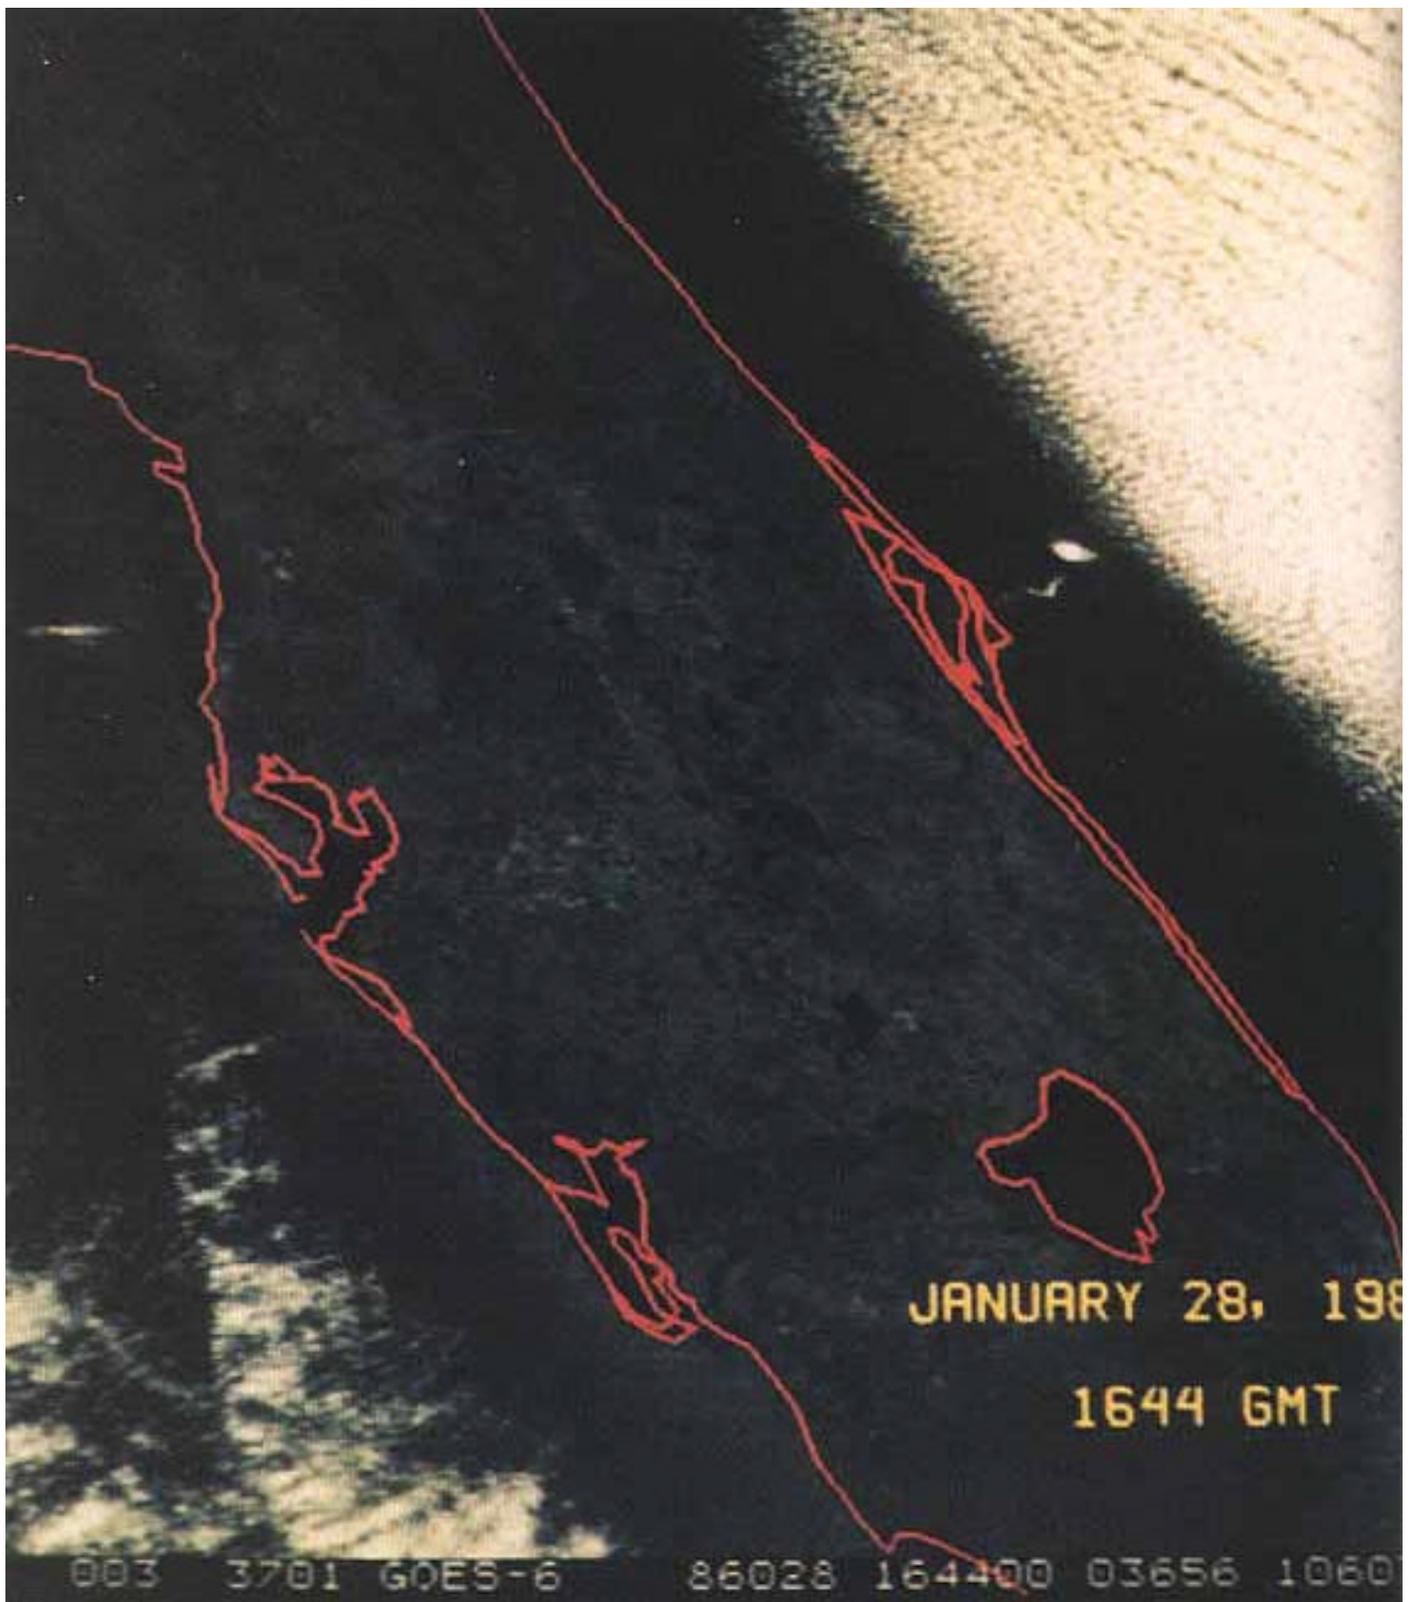
At 11:44 a.m. Eastern Standard Time, a GOES environment-monitoring satellite operated by the National Oceanic and Atmospheric Administration acquired this image of the smoke and vapor cloud from the 51-L accident. The coast of Florida is outlined in red.

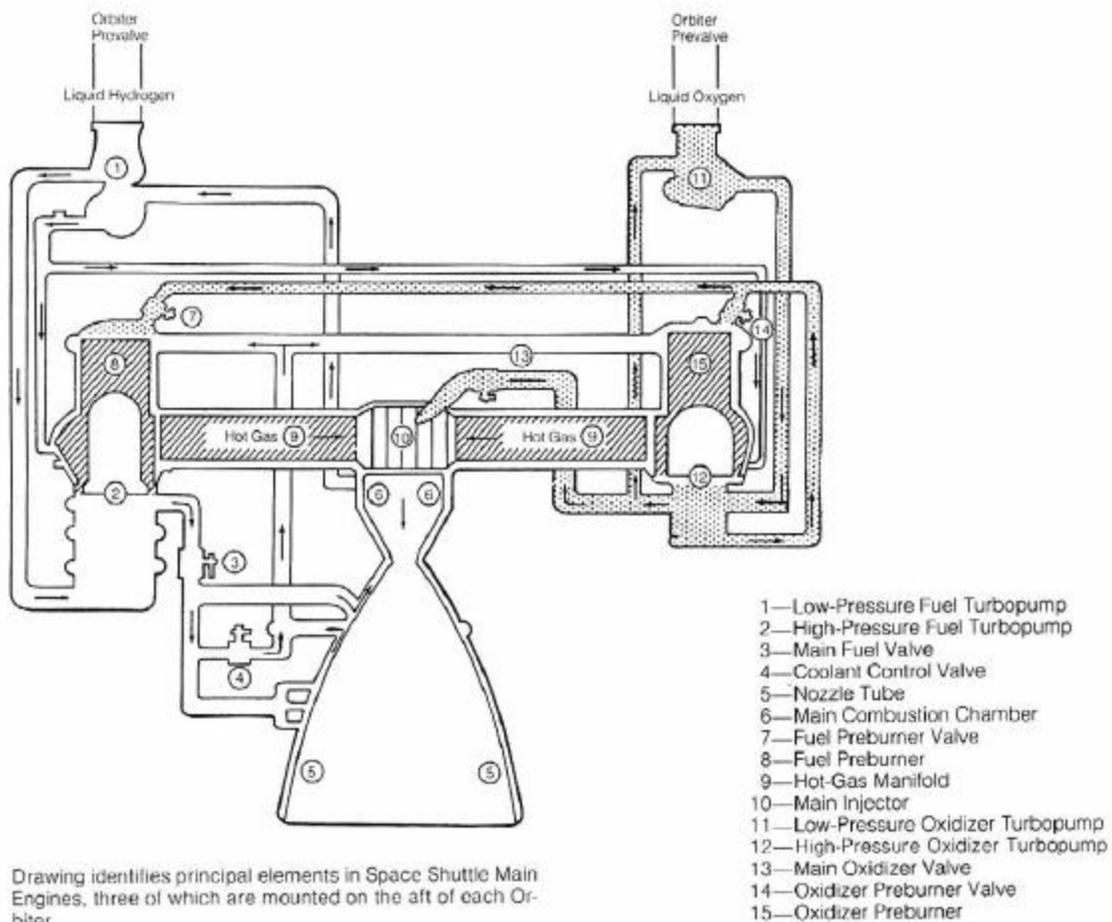
Figure 4

The first abnormal engine indication was a drop in engine fuel tank pressure at 72.564 seconds. As fuel pressure dropped, the control system automatically responded by opening the fuel flowrate valve. The turbine temperatures then increased because of the leaner fuel mixture.

The increased temperature caused an increase in pump speed. This could not, however, increase the fuel pressure because of a decrease in fuel tank top (ullage) pressure resulting from the burned through hydrogen tank leakage. When the fuel pump pressures dropped below 140 pounds per square inch, the programmed control system disqualified the measured data because it was past reasonable limits. This caused the fuel flowrate and high-pressure fuel pump discharge pressure to decrease, while the lack of load allowed the pump's speed to increase. The decreased fuel flow caused a drop in fuel preburner chamber pressure, though the fuel preburner oxygen valve was then advancing toward a more open position. The mixture ratio in the fuel preburner became leaner, which raised high-pressure fuel turbine discharge temperatures above the redline limits. This caused the engine control system to start automatic shutdown of the engine.

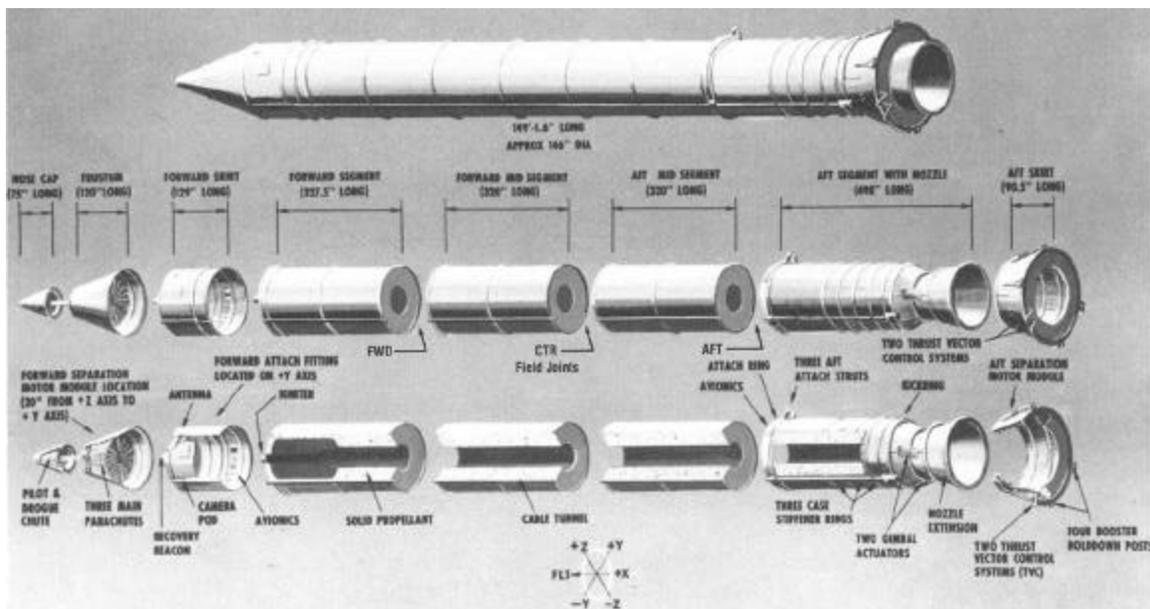
Figure 8. Solid Rocket Booster drawing at top is exploded in lower drawing to show motor segments and other elements at forward and aft ends of booster.

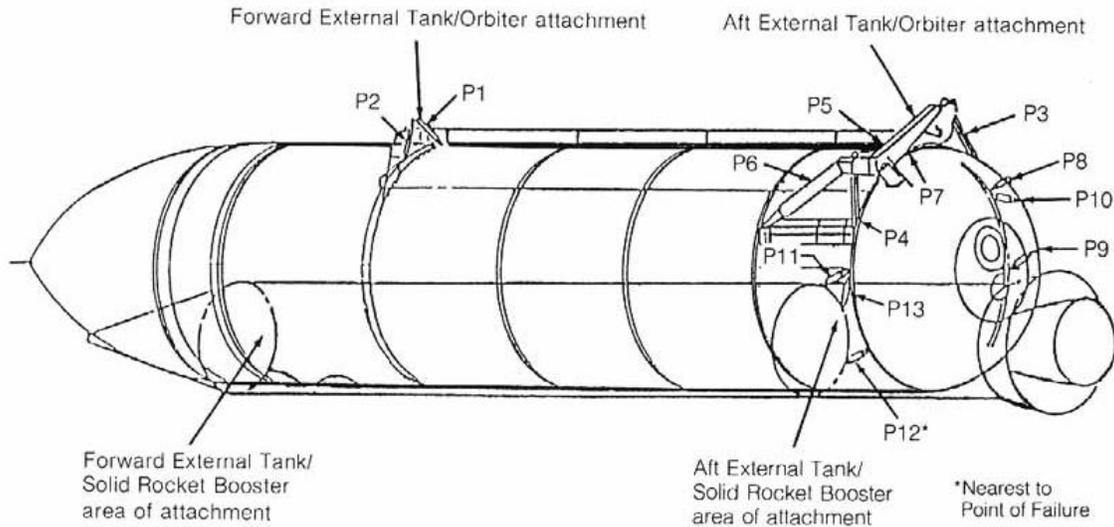
Figure 10  
Drawing of transparent External Tank, with right Solid Rocket Booster on far side, shows location of struts measured in table of strut loads. (Figure 9)

The STS 51-L lift off loads were compared to design loads and flight measured loads for STS-1 through STS-7 (Figure 9). The Shuttle strut identification is shown in Figure 10. The loads measured on the struts are good indicators of stress since all loads between Shuttle elements are carried through the struts. The STS 51-L lift off loads were within the design limit.

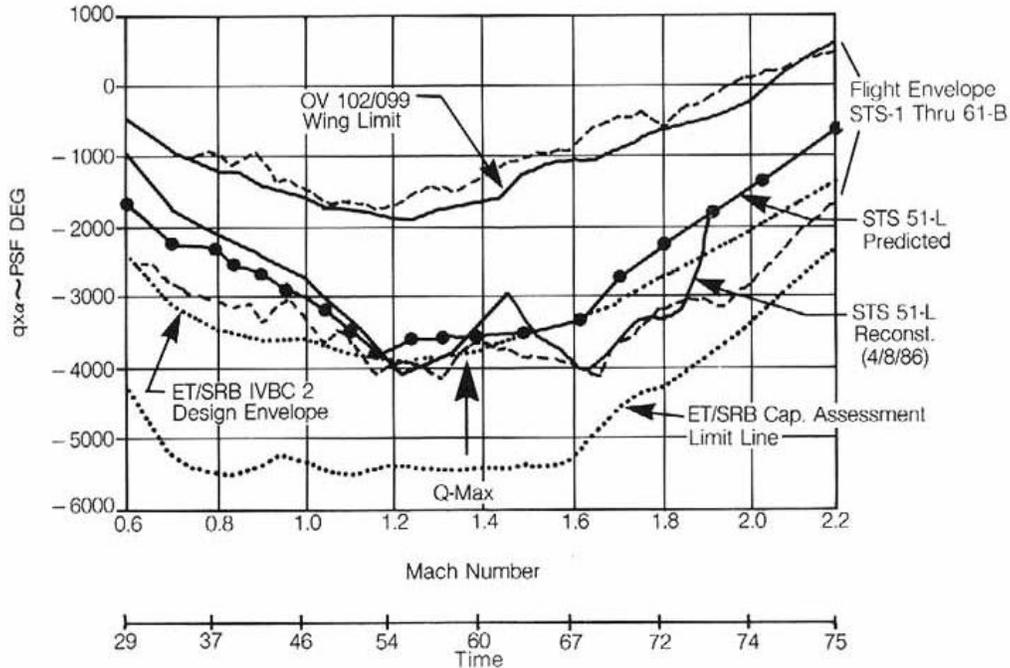
Figure 11

The Solid Rocket Motor field joint axial tension loads were substantially lower at maximum dynamic pressure than at lift off:  $11.6 \times 10^6$  pounds for the forward field joint and  $10.6 \times 10^6$  pounds for the aft field joint. Compared to the internal pressure loads, the dynamic variations due to wind shear were small—about 1/15 those of the pressure loads. These loads were well below the design limit loads and were not considered the cause of the accident.

The loads in the pitch plane are shown by the solid line marked "STS 51-L RECONST." The curve "STS 51-L PREDICTED" give the loads expected before the flight. The dashed lines show the limit of experience from STS-1 through 61-B. The present design limits are the two lines marked "OV102/099 WING LIMIT" above, and "ET/SRB CAP. ASSESSMENT LIMIT LINE" below. (After STS-6, the wing was strengthened. The previous design limits were "ET/SRB IVBC 2 DESIGN ENVELOPE" below, and a curve in the position region of  $q \times \alpha$  above).

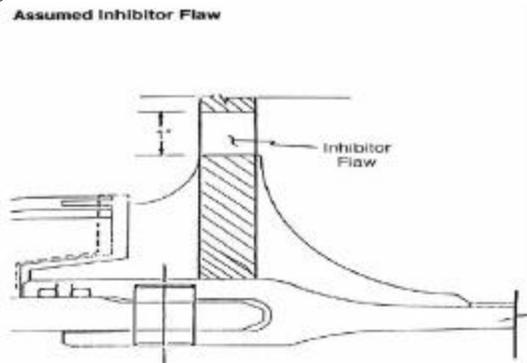
Figure 12  
Sketch shows location of assumed inhibitor flaw used in eliminating such a problem as a possible cause.

case larger than one inch would cause the entire case to rupture in a few milliseconds. This would give rise to the appearance of a large longitudinal flame, an event that is contrary to the flight films. Evaluation of potential insulation or inhibitor (see [Figure 12](#)) flaws against the three criteria above resulted in elimination of all candidates except a defect in the forward-facing inhibitor. This potential failure mode was evaluated by assuming a 1-inch-diameter hole in the inhibitor. Analysis indicated that the change in motor internal pressure resulting from this failure would probably not be detected. However, an erosion rate substantially higher than the observed values would be required to burn through the membrane by 58 seconds. In addition, the assumed flaw is unlikely since the inhibitor is constructed by vulcanizing eight individual plies of the material. Subsequent damage of the magnitude required is improbable and would be easily detected.

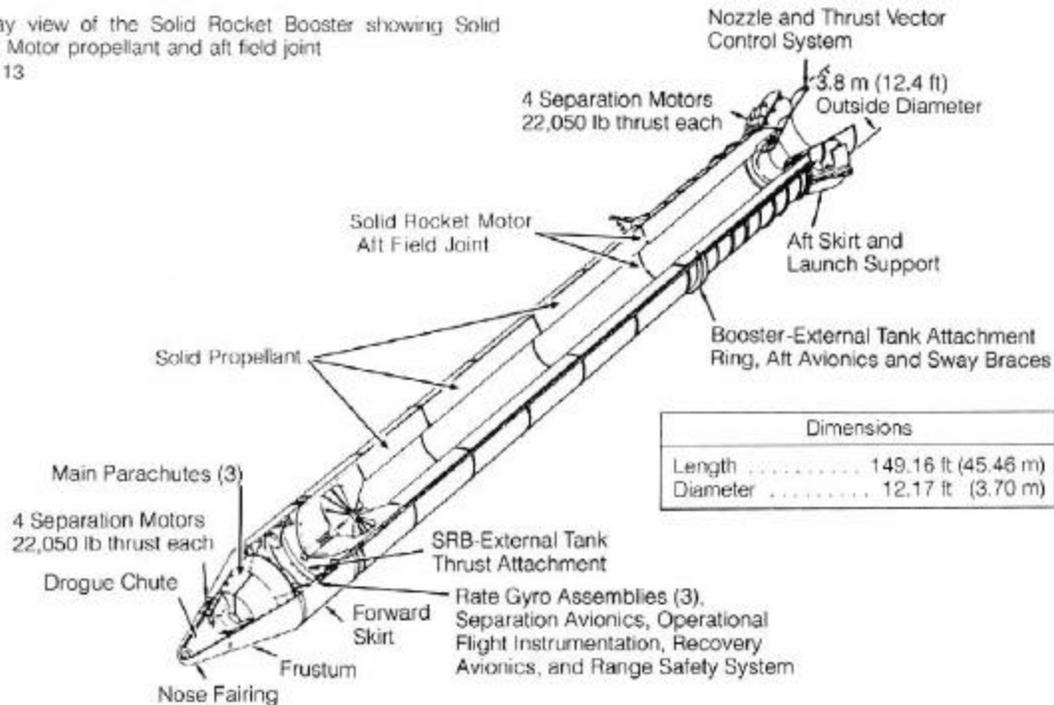
Cutaway view of the Solid Rocket Booster showing Solid Rocket Motor propellant and aft field joint  
Figure 13

During stacking operations at the launch site, four segments are assembled to form the Solid Rocket Motor. The resulting joints are referred to as field joints, located as depicted in Figures 8 and 13. Joint sealing is provided by two rubber O-rings with diameters of 0.280 inches (+0.005, -0.003), which are installed, as received from Morton Thiokol, during motor assembly. O-ring static compression during and after assembly is dictated by the width of the gap between the tang and the inside leg of the clevis. This gap between the tang and clevis at any location after assembly is influenced by the size and shape (concentricity) of the segments as well

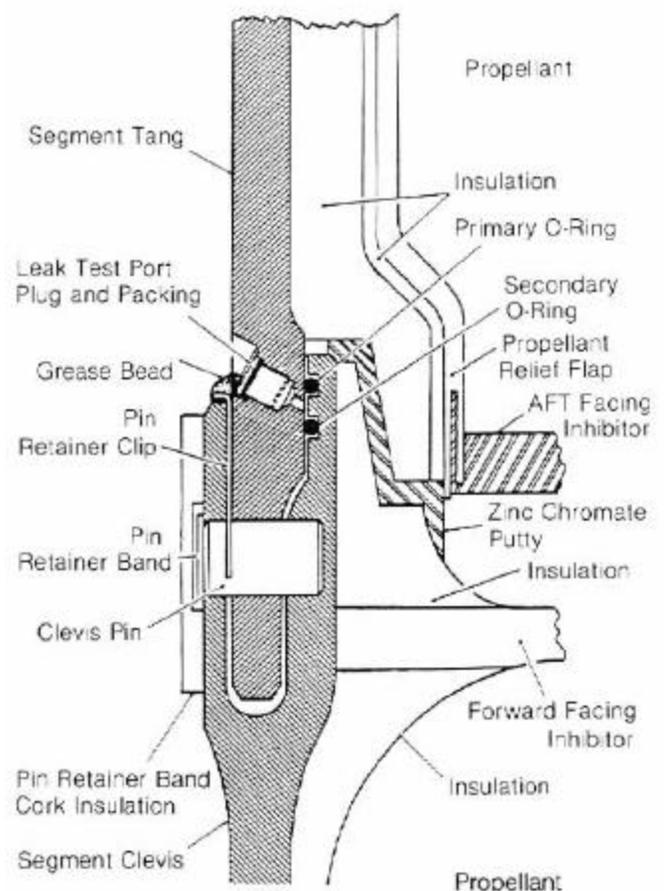
Figure 14  
Solid Rocket Motor cross section shows positions of tang, clevis and O-rings. Putty lines the joint on the side toward the propellant.

pressure loads are applied to the joint during ignition. Should pressure actuation be delayed to the extent that the gap has opened considerably, the possibility exists that the rocket's combustion gases will blow by the O-ring and damage or destroy the seals. The principal factor influencing the size of the gap opening is motor pressure; but, gap opening is also influenced by external loads and other joint dynamics. The investigation has shown that the joint sealing performance is sensitive to the following factors, either independently or in combination:

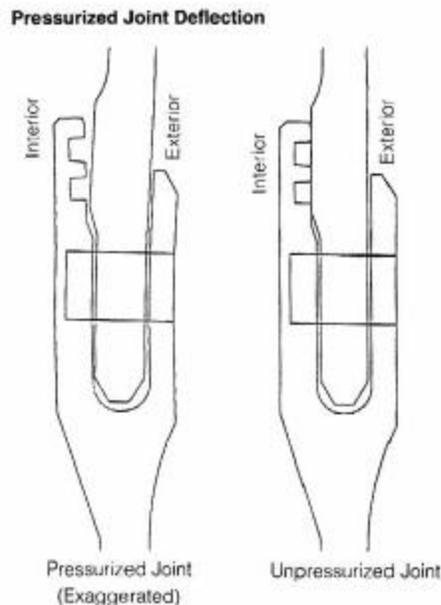
The joint deflection analysis established time histories for gap openings for primary and secondary O-rings for all field joints. For the aft field joints these data indicate gap opening increases of approximately 0.029 inches and 0.017 inches for the primary and secondary O-rings respectively. These values were used for sub-scale dynamic tests. Due to differences in motor pressure and loads, the gap opening increases for forward field joints are approximately 0.008 inches greater than for the aft field joints. Gap opening changes (called delta gap openings) versus time are shown in [Figure 17](#) for the aft field joints. The total gap at any time also depends on the initial static gap, on rounding effects during segment pressurization, and on loadings due to struts and airloads. Sub-scale tests were run containing combinations of the above variables, but did not include the effects of the struts and airloads

Figure 16 Drawings show how tang/clevis joint deflects during pressurization to open gap at location of O-ring slots. Inside of motor case and propellant are left in sketches.

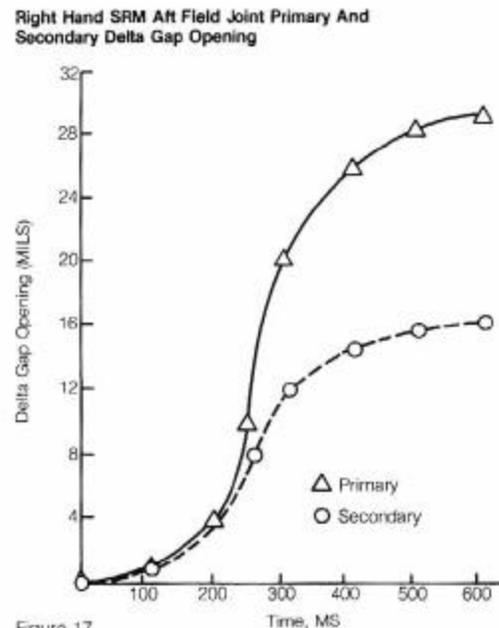
Figure 17 Graph plots changes in right booster's aft field joint primary and secondary gap openings. Horizontal scale is time in milliseconds from ignition.

Consistent results from numerous O-ring tests have shown a resiliency degradation with reduced temperatures. [Figure 23](#) provides O-ring recovery from 0.040 inches of initial compression versus time. This shows how quickly an O-ring will move back towards its uncompressed shape at temperatures ranging from 10 to 75 degrees Fahrenheit. When these data are compared with the gap openings versus time from [Figure 17](#), it can be seen that the O-rings will not track or

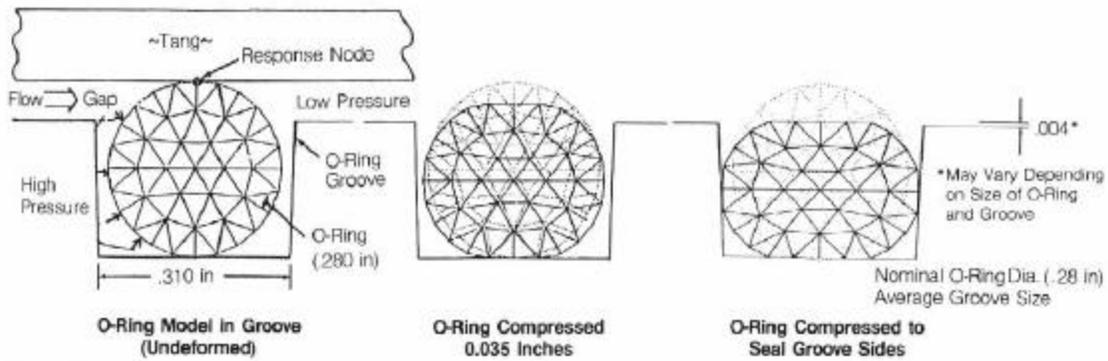
Figure 18  
 Drawings show how progressive reduction of gap between tang and clevis can inhibit and eventually block motor cavity's high-pressure flow from getting behind O-ring.

Recent analysis has shown and tests tend to confirm that O-ring sealing performance is significantly improved when actuating pressure can get behind the entire face of the O-ring on the upstream side of the groove within which the O-ring sits (Figure 18). If the groove is too narrow or if the initial squeeze is so great as to compress the O-ring to the extent that it fills the entire groove and contacts all groove surfaces, pressure actuation of the seal could be inhibited.
