Report to the President

**PRESIDENTIAL  
COMMISSION**

On the Space Shuttle  
Challenger Accident

June 6th, 1986  
Washington, D.C.

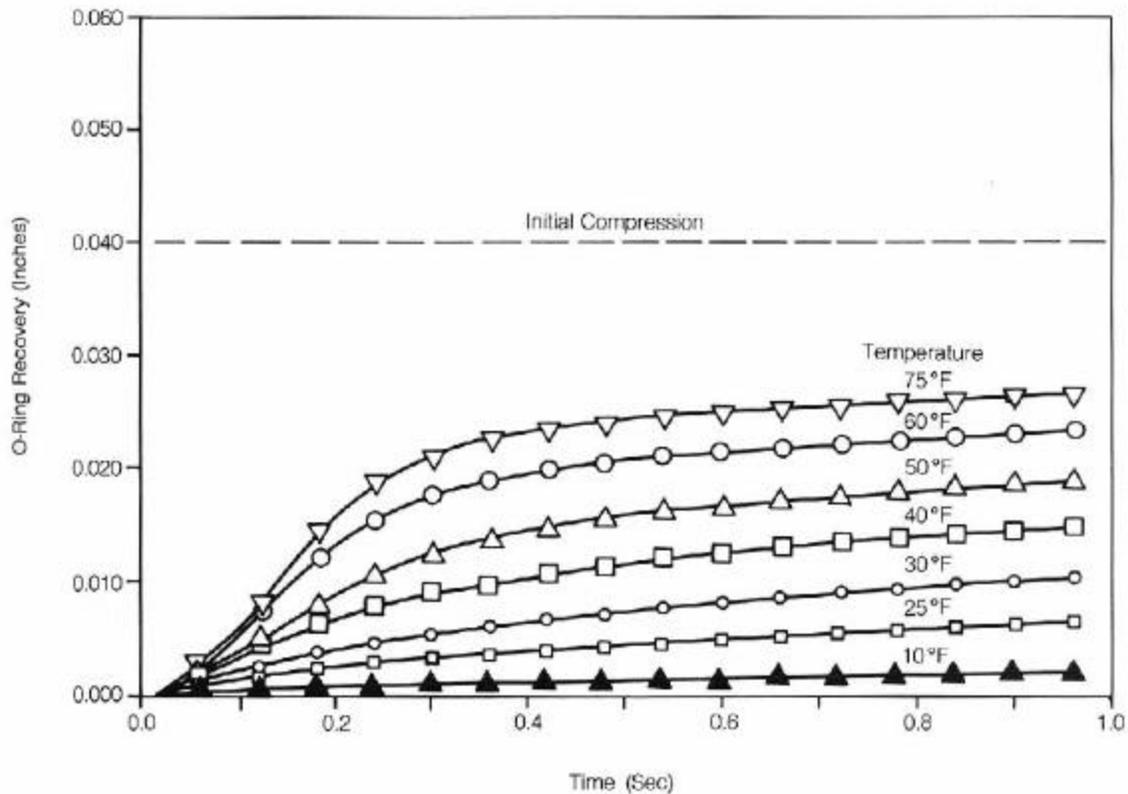
**O-Ring Recovery vs. Time**

Consistent results from numerous O-ring tests have shown a resiliency degradation with reduced temperatures. [Figure 23](#) provides O-ring recovery from 0.040 inches of initial compression versus time. This shows how quickly an O-ring will move back towards its uncompressed shape at temperatures ranging from 10 to 75 degrees Fahrenheit. When these data are compared with the gap openings versus time from [Figure 17](#), it can be seen that the O-rings will not track or

Figure 23. **O-Ring Recovery vs. Time.** Graph plots O-ring shape recovery in inches against time in seconds for a variety of temperatures. Note: Average O-ring Recovery at Various Test Temperatures During First Second After Load Release. Initial Compression of 40 Mills was Maintained for 2 hours.

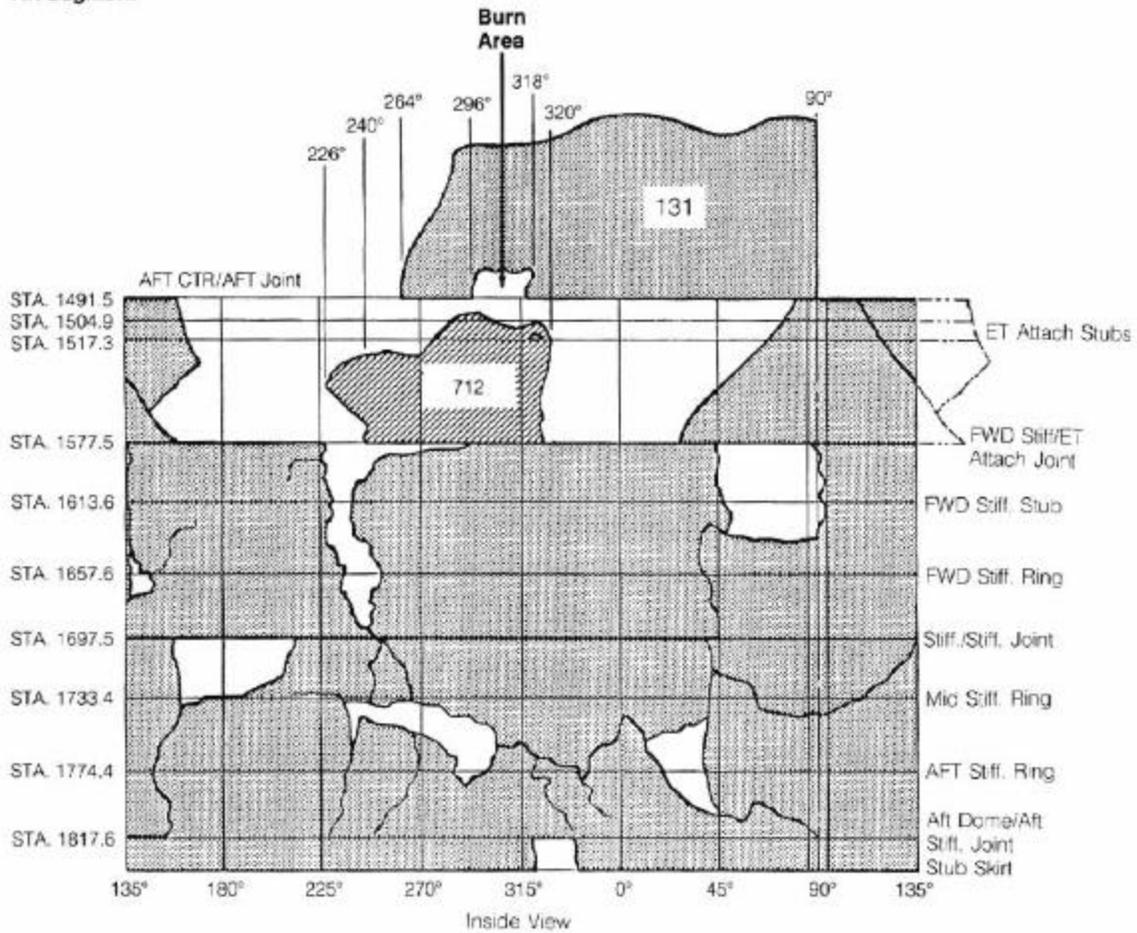
**RH SRB Recovered Debris  
Aft Segment**

Drawing depicts pieces of right Solid Rocket Booster aft segment recovered. At top is piece of aft center segment.

Figure 25 shows a sketch of an interior unrolled view of the aft part of the right hand Solid Rocket Booster with the recovered burned pieces 131 and 712 noted. The critical region is

between parts 131, the upper segment tang region, and part 712, the lower clevis region of the joint. This burned area extends roughly from station 1476, in the upper section, to 1517 on the lower region. In a circumferential direction (see figure 26) the lower end of the eroded region extends from roughly 291 degrees to 320 degrees and the upper eroded section extends between 296 and 318 degrees. Note that the region at about 314 degrees includes the attachment region of the strut to the attachment ring on the right Solid Rocket Booster.

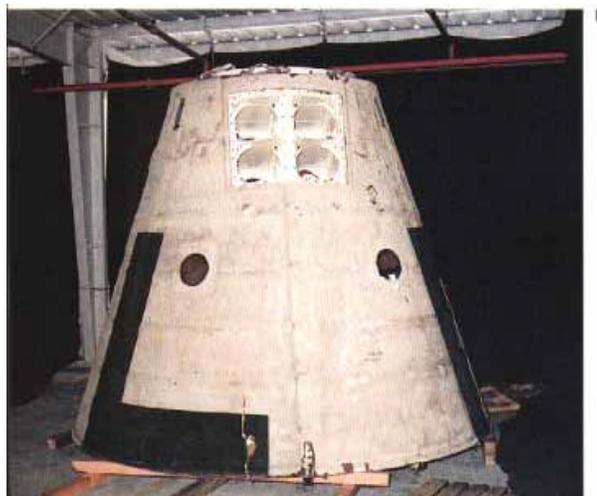
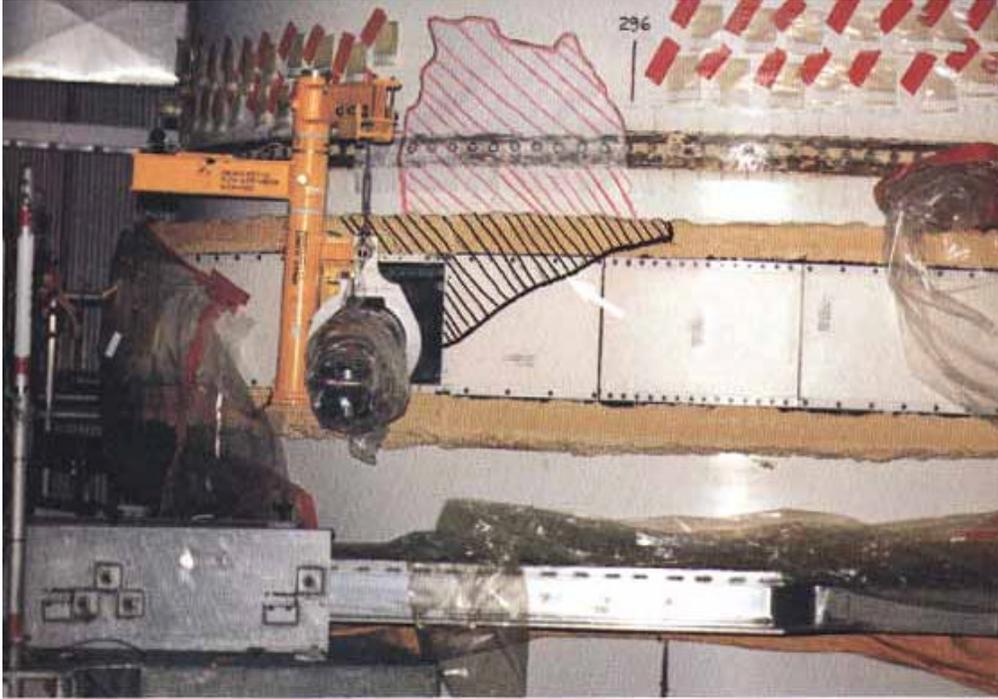
G

The frustum of the nose cone of the right Solid Rocket Booster was damaged (photo [E](#)) as if it had struck the External Tank, but there were no signs of thermal distress. The frustum of the nose cone of the left Solid Rocket Booster (photo [E](#)) was essentially undamaged.

strut. This location was within the center of the burned out zone on the right Solid Rocket Booster (photo G). As a matter of interest, the P12 strut is located close to the point on the circumference where the booster case experiences maximum radial deflection due to flight loads. It seems likely that the plume from the hole in the booster would impact near the location of the P12 strut connection and the External Tank. Using geometric considerations alone suggests this strut separated from the External Tank before it separated from the right hand Solid Rocket Booster.

The frustrums on the left page are parts of the Solid Rocket Booster forward assemblies that contain recovery parachutes, location aids and flotation devices. The frustrum of the left hand booster (lower left) is virtually undamaged. The right frustrum shows impact damage at top and burns along the base of the cone; evidence indicates it was damaged when it impacted with the External Tank. Shown at right above is another Solid Rocket Motor stack crosshatched to show the burned area of the right booster's aft joint (diagram at right). The flame from the hole impinged on the External Tank and caused a failure at the aft connection at the External Tank.

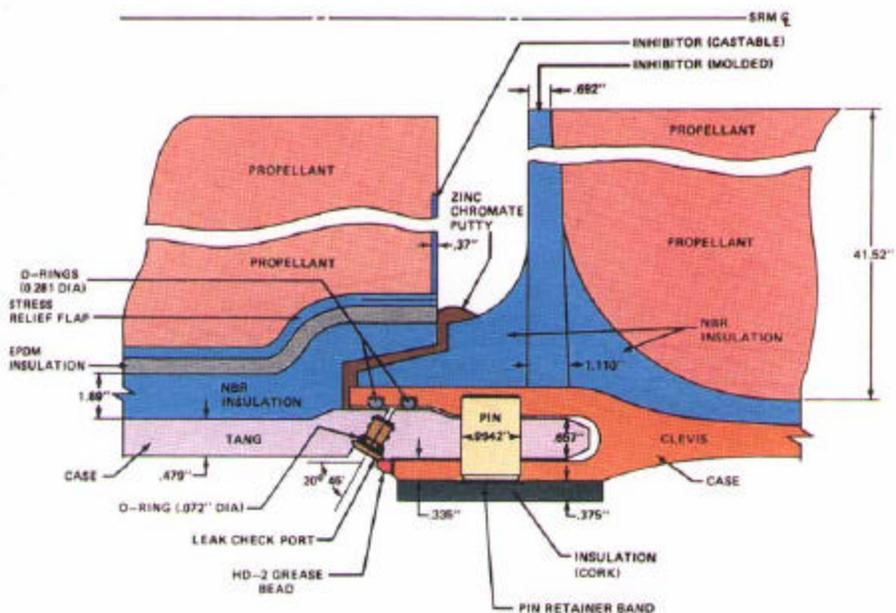
H

AFT SEGMENT/AFT CENTER SEGMENT FIELD JOINT CONFIGURATION

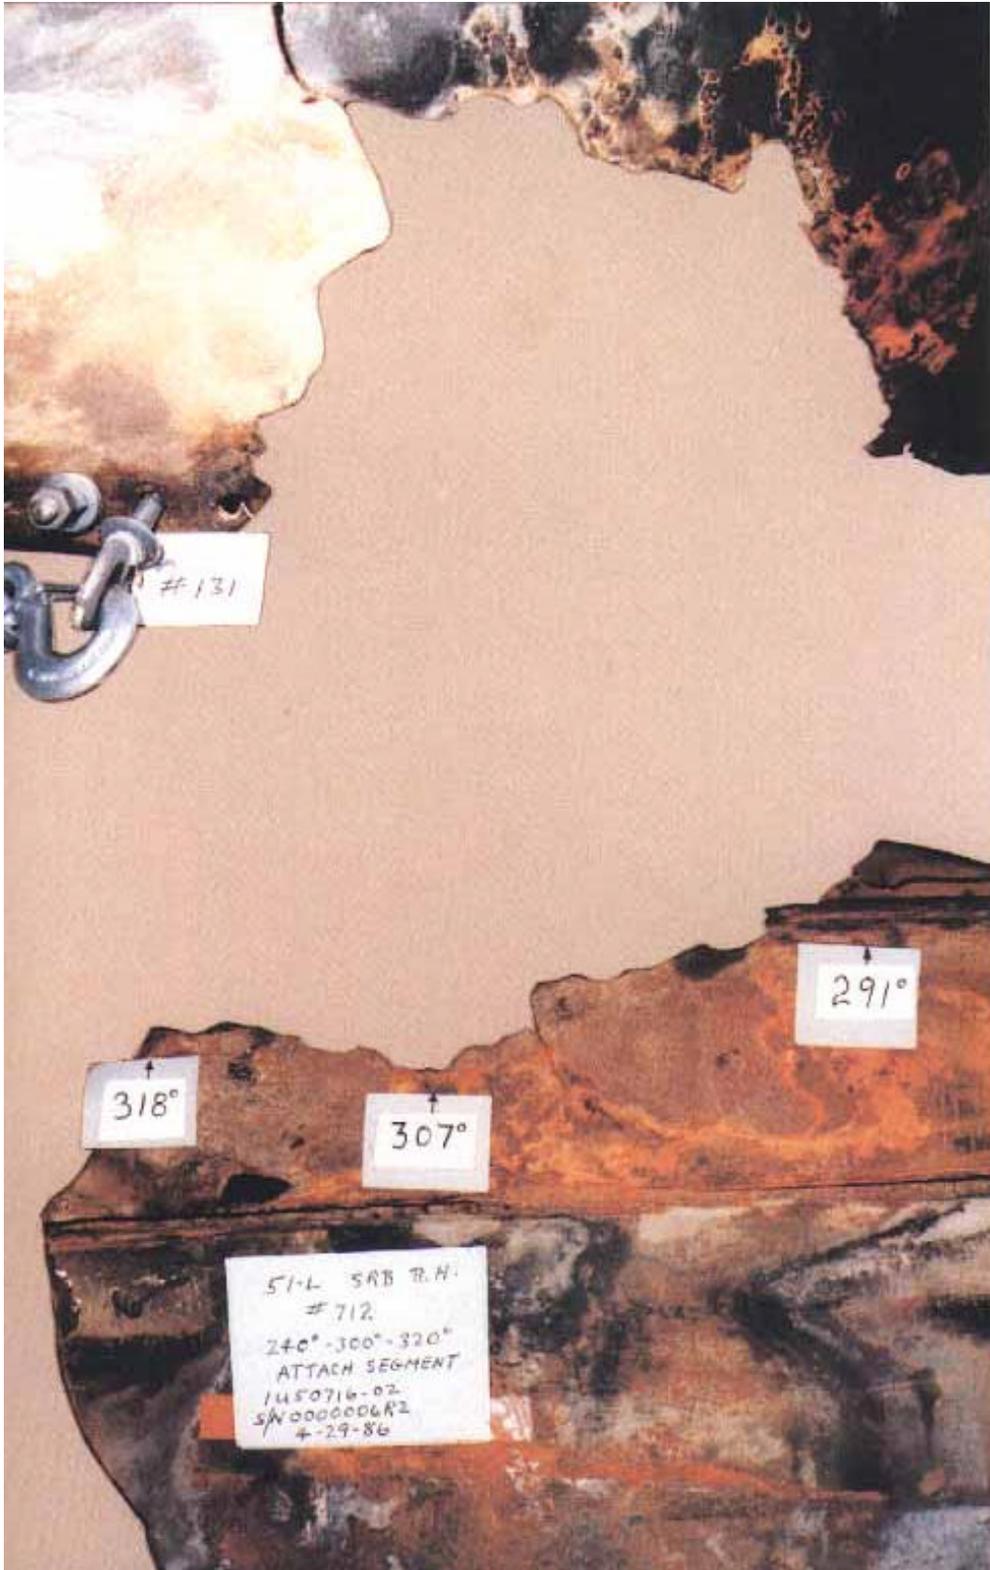
The part of the aft section of the right Solid Rocket Booster in the circumferential position of the hole was recovered (photos [L](#) and [N](#)). This piece, contact 712, showed evidence of a burned hole edge extending from 291 degrees to 318 degrees, approximately 33 inches long (see bracket, photo [L](#)). The burned surface extended into the aft attach stub region of the case adjacent to the P 12 strut attach point. The box structure of the aft attachment ring was missing from the attach stubs. The piece displayed fractures which led circumferentially or aft from the hole and the burned surface. Booster pieces on either side have not been recovered. Thus in the burn area no portion of the clevis or attachment ring other than the stubs was available for examination .

The exterior surface of the aft case piece also contained a large heat affected area (photo [M](#)). The shape and location of this area indicates a plume impingement from the escaping gases. The light colored material at the downstream edge of the area is probably asbestos from the insulator. The rust colored line more or less parallel to the stubs may be a stagnation line produced in the gas flow when the gases passed around the attachment ring. Secondary flow of metal from the aft attach stub ring also shows this feature. There was a small burn hole in the case wall (arrow, photo [O](#)) which appeared to have penetrated the case from the exterior toward the interior. This may also have been due to a swirling flow of hot gases within the attachment ring box structure. The shadow of the insulation downstream of the attach box can also be seen. This evidence suggests strongly that a hot gas plume impinged against the attachment ring, passed around and through it, and ultimately destroyed its structural integrity, probably late in the flight of the Solid Rocket Booster.

The photographs [L](#), [M](#), [N](#), and [O](#) view the lower case piece in the inverted position. A correct orientation of this piece is shown in a composite view of the burn area located in photo [P](#).

Photos N & O [top, bottom]  
At upper left is the aft segment burn viewed from inside the casing; the lower photo is a closeup of the same section. The latter photo shows a hole (arrow) where the flame plume may have burned through the casing from the outside. At right is a composite view of the burn above and below the aft field joint.

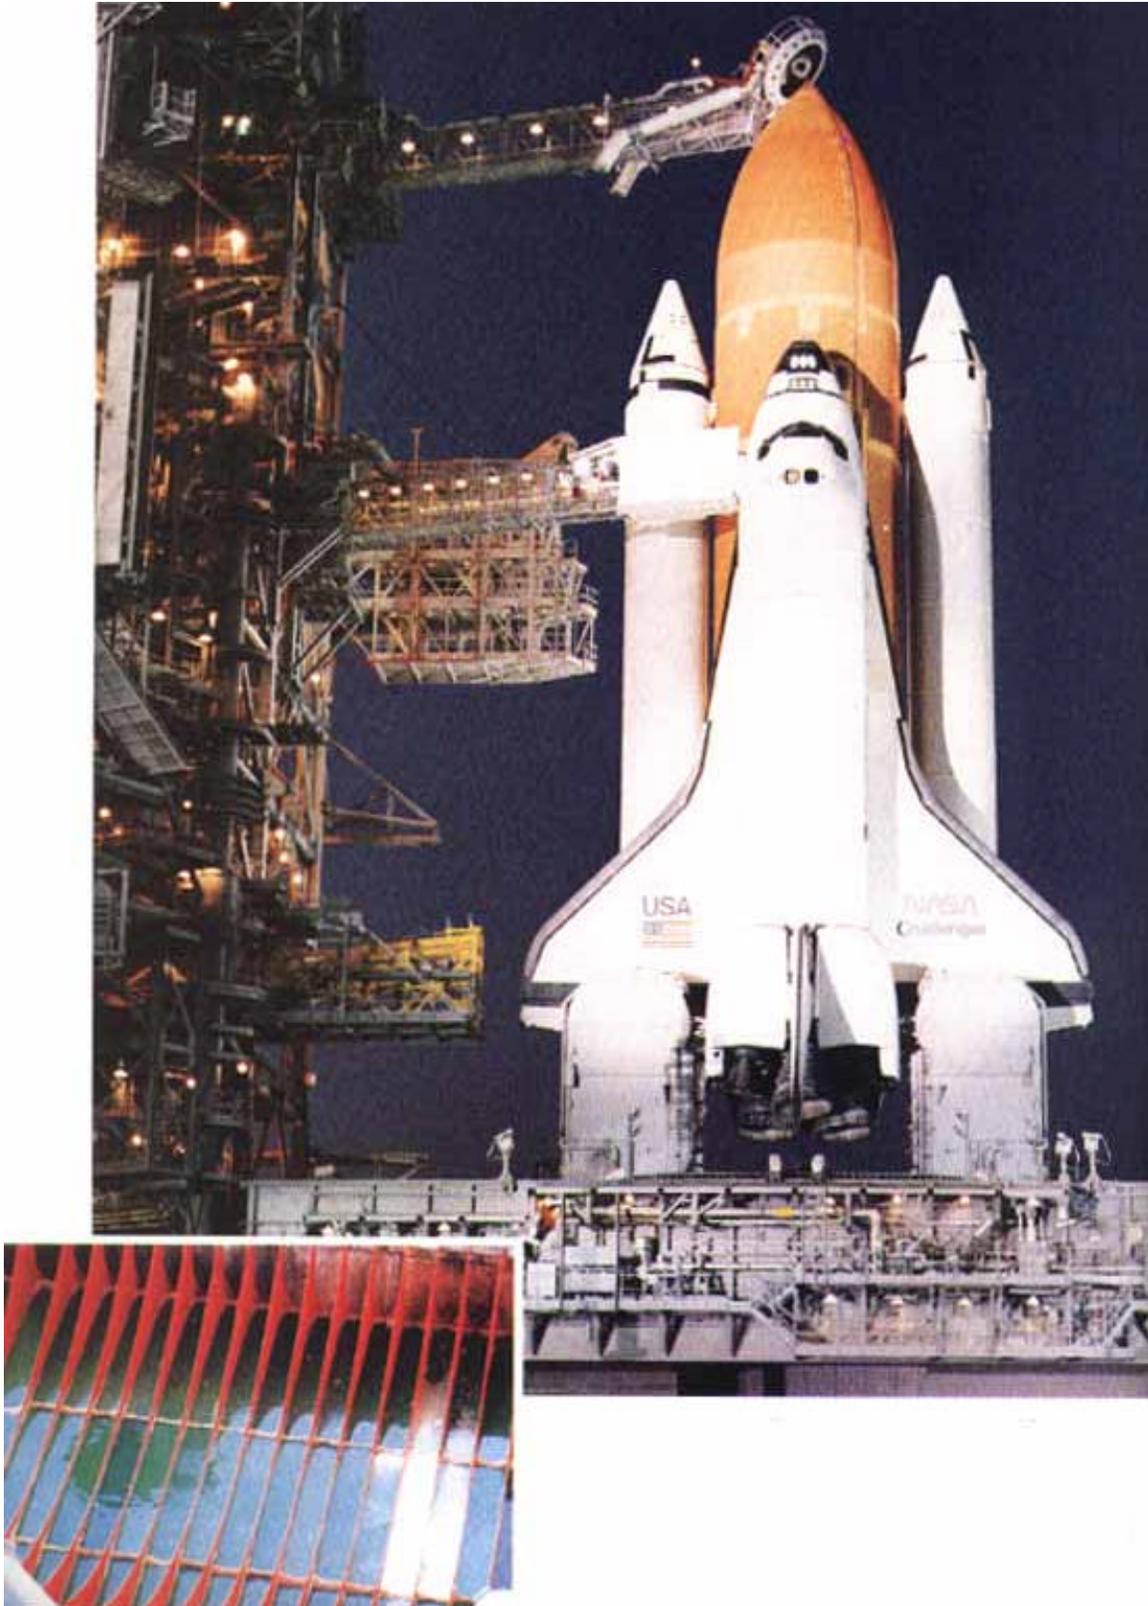
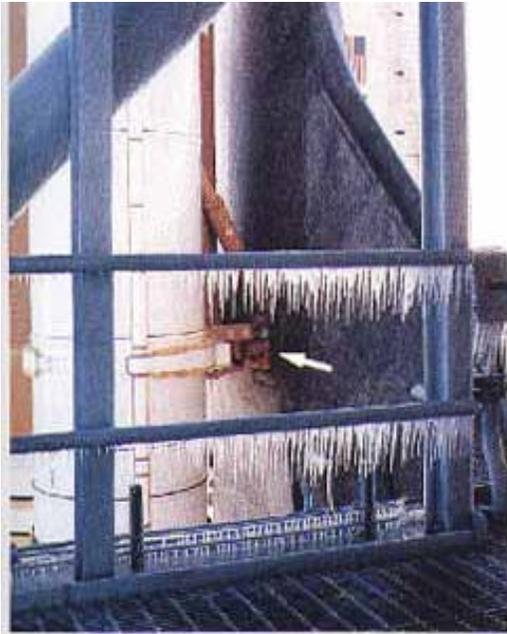
Above, Shuttle 51-L on Kennedy Space Center Pad 39B in the early morning of launch day. Temperatures were well below freezing, as indicated by the lower left photo, which shows thick ice in a water trough despite the use of an anti-freeze solution.

Above, foot long icicles on a lower level of the Fixed Service Structure frame the attachment point where the Orbiter is attached to the external tank (arrow). Icing was even more extensive at upper levels of the service structure (upper right and below). At right below is a ground communications box (not used during launch) rendered inoperable by heavy ice.

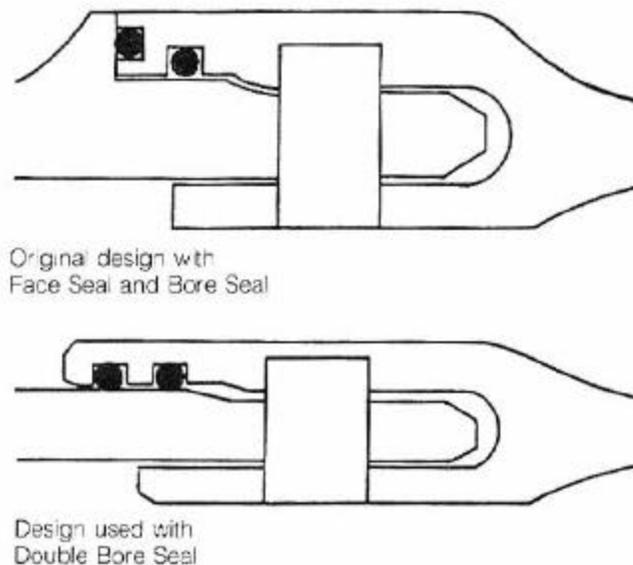
Figure 1

The initial Thiokol design proposal was changed before the production motors were manufactured. Originally, the joint seal design incorporated both a face seal and a bore seal.<sup>16</sup> (Figure 1.) However, the motor that was eventually used had double bore O-rings. The original bore seal/face seal design was chosen because it was anticipated that it "provides [better] redundancy over a double bore ring seal since each is controlled by different manufacturing tolerances, and each responds differently during joint assembly." <sup>17</sup> Because the early design incorporated tolerances similar to the Titan and it also incorporated a face seal, Thiokol believed it possessed "complete, redundant seal capability."<sup>18</sup> Nevertheless, as the Solid Rocket Motor program progressed, Thiokol with NASA's concurrence dropped the face/bore seal design for one using a double bore seal (Figure 1). NASA engineers at Marshall said the original design would have required tapered pins to maintain necessary tolerances and assure enough "squeeze" on the face-sealing O-ring.<sup>19</sup> However, design analysis determined that motor ignition would create tension loads on the joint sufficient to cause the tapered pins to pop out. Solving that would have meant designing some type of pin-retainers. Moreover, the rocket assembly was much easier with the dual bore seals. Because inspections and tests had to be conducted on the Solid Rocket Motor stack, horizontal assembly was required. Thiokol engineer, Howard McIntosh, described this in a Commission interview on April 2, 1986:

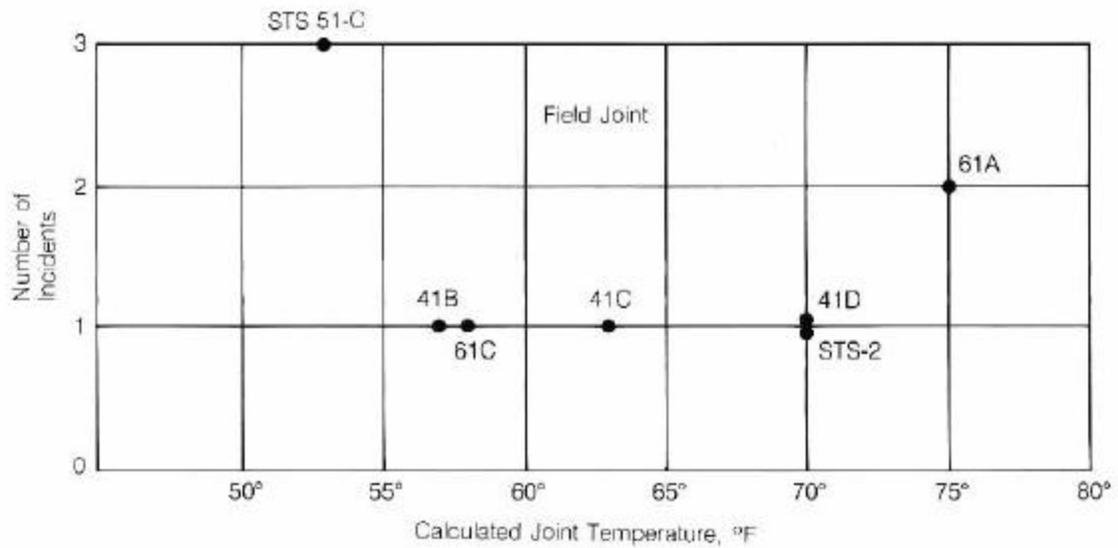
not the frequency of occurrence based on all flights (Figure 6). In such a comparison, there is nothing irregular in the distribution of O-ring "distress" over the spectrum of joint temperatures at launch between 53 degrees Fahrenheit and 75 degrees Fahrenheit. When the entire history of flight experience is considered, including "normal" flights with no erosion or blow-by, the comparison is substantially different (Figure 7).

Figure 6  
Plot of flights with incidents of O-ring thermal distress as function of temperature

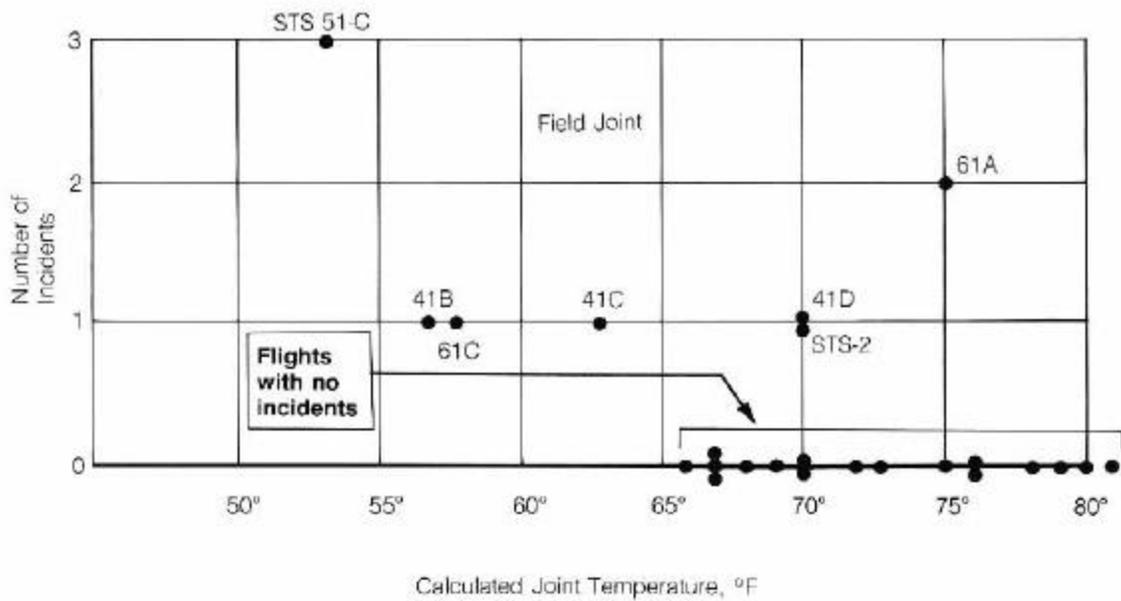
Figure 7  
Plot of flights with and without incidents of O-ring thermal distress

NOTE: Thermal distress defined as O-ring erosion, blow-by, or excessive heating
